## CASE STUDY

### *ESPINHO - 100 years of Beach Protection*

*Espinho, Aveiro, Portugal*

*Beach Protection*

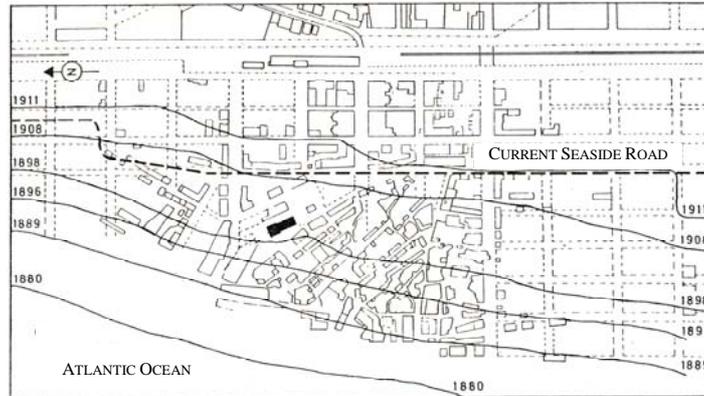
Since the construction of the first sea defences in 1909 (destroyed in 1911), successive generations have watched the Espinho coastline retreating and progressing, landward and seaward by many meters. For instance, between 1885 and 1910 the shoreline retreated 225m – this corresponds to the amazing erosion rate of 9m/year, and the old village centre was almost completely swallowed by the sea (Figure 2).

Figure 2. Coastal retreat in Espinho between 1880 e 1911 (Mota Oliveira & Martins, 1991).

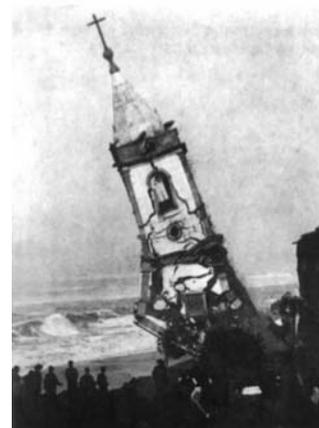
The sea destroyed the Chapel built in 1906. In February a storm caused slight damage on the seawall. In December a very severe storm caused the destruction of 40m of the wall and 60m of the back wall.

Figure 5. Holy Mary of Help Chapel destruction.

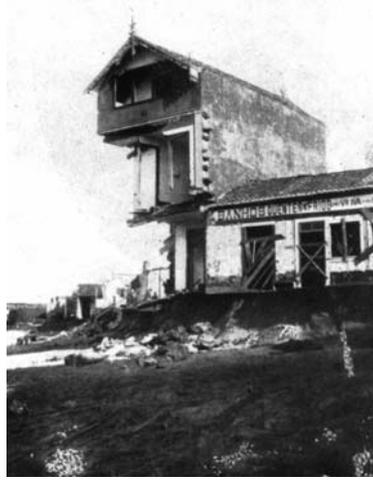
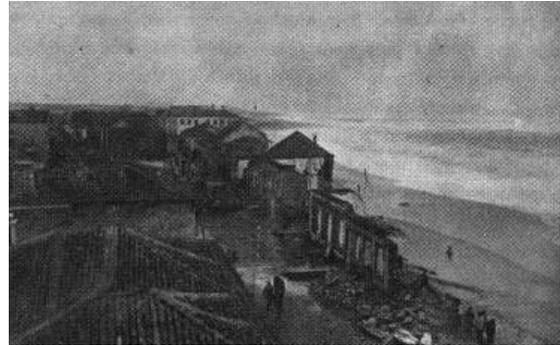
Figure 6. Houses destroyed.

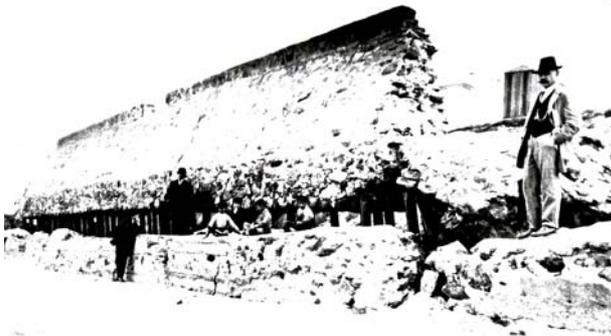
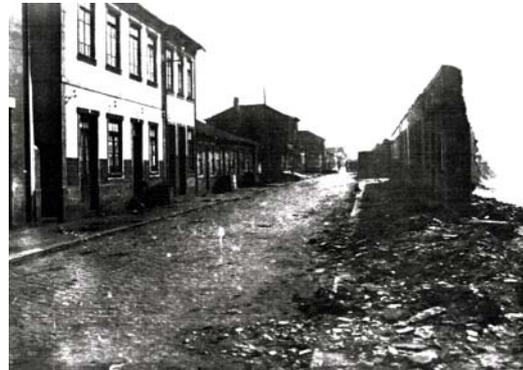
Figure 7. Wall destruction.

After the destruction of the wall, reconstruction works were promptly started. At the end of January the reconstruction works were stopped after almost complete destruction by a new severe storm. In the meantime, as an experiment, two wooden groyne were built and the beach grew slightly.

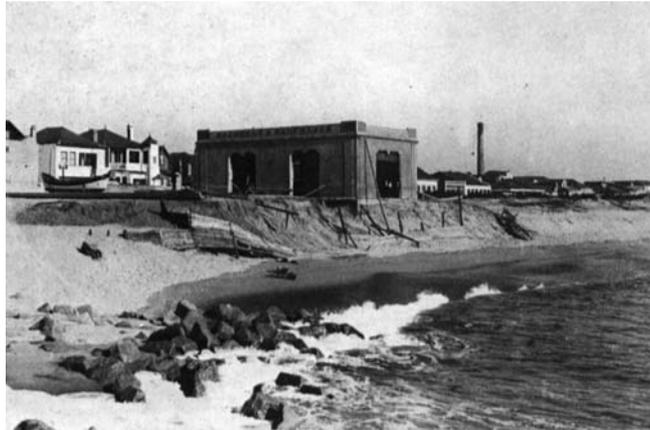
The life-saving shelter, built in 1928, was destroyed.

Figure 10. Life-saving shelter.

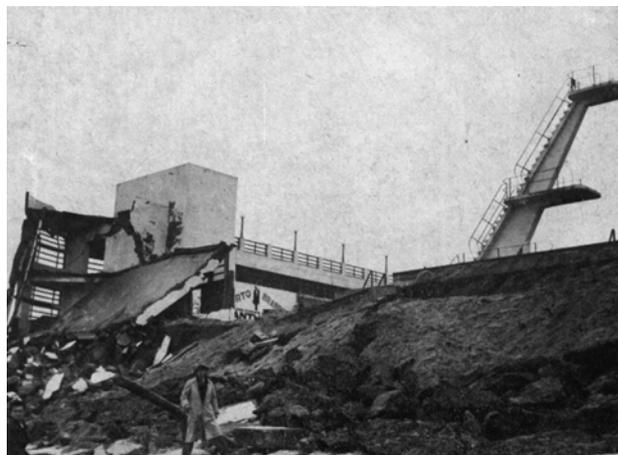
In February, the wooden wall between 27<sup>th</sup> and 31<sup>st</sup> was completed. The north side of the swimming pool was destroyed and its foundations were laid open.

Figure 13. The sea reaches the swimming pool.

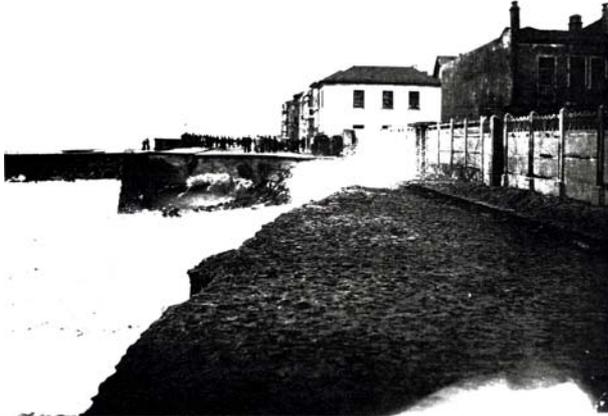
Figure 15. 2<sup>nd</sup> street destruction.

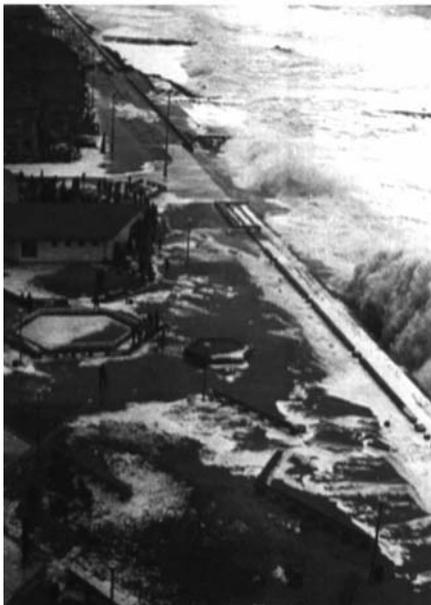
The Espinho littoral was again subjected to violent sea attacks. On 2<sup>nd</sup> street the pavement was ruined by wave energy and the north part of 8<sup>th</sup> Avenue was partly destroyed.

Figure 18. 1979 Storms.
