## CASE STUDY

### *Esposende – Ofir stretch*

*Development Pressures*

*Coastal erosion*

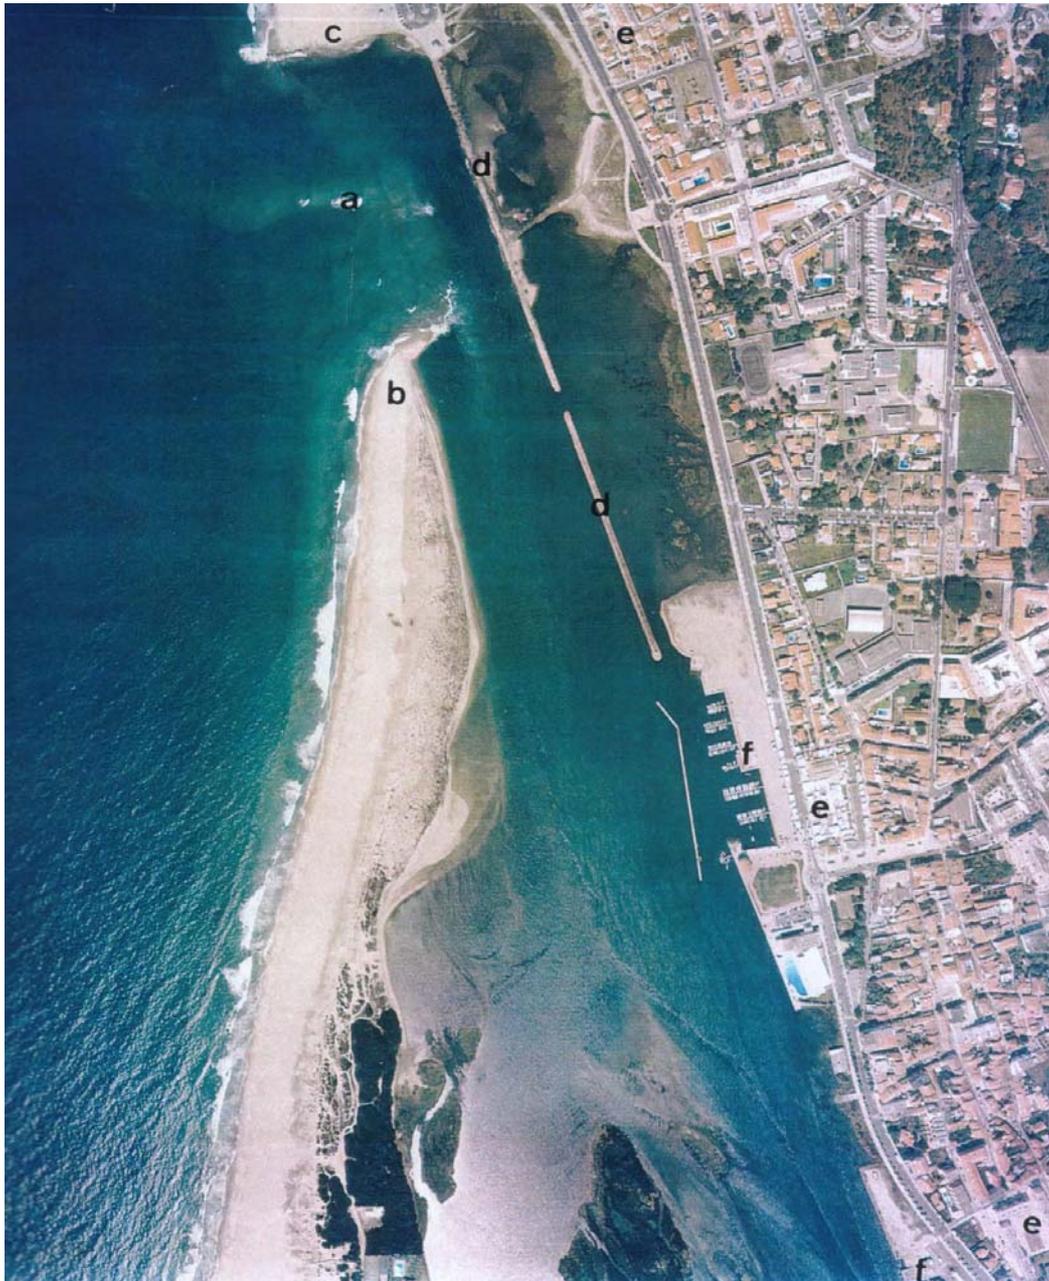
Figure 2. Mouth of *Cávado* and southern coastal stretch  
(Orto-photograph: INAG, September 17, 2001).

Legend:

- (a) river *Cávado* mouth;
- (b) northern part of the sand-spit;
- (c) northern dique;
- (d) longitudinal dique (right bank);
- (e) *Esposende*;
- (f) Marina and fisherman harbour;

- Northern dique of the river *Cávado* mouth (right bank), Figure 2;
- Curved groyne between the *Cávado* sand-spit and *Ofir*, Figure 3;
- *Ofir* groyne (southwards the hotel), Figure 3;

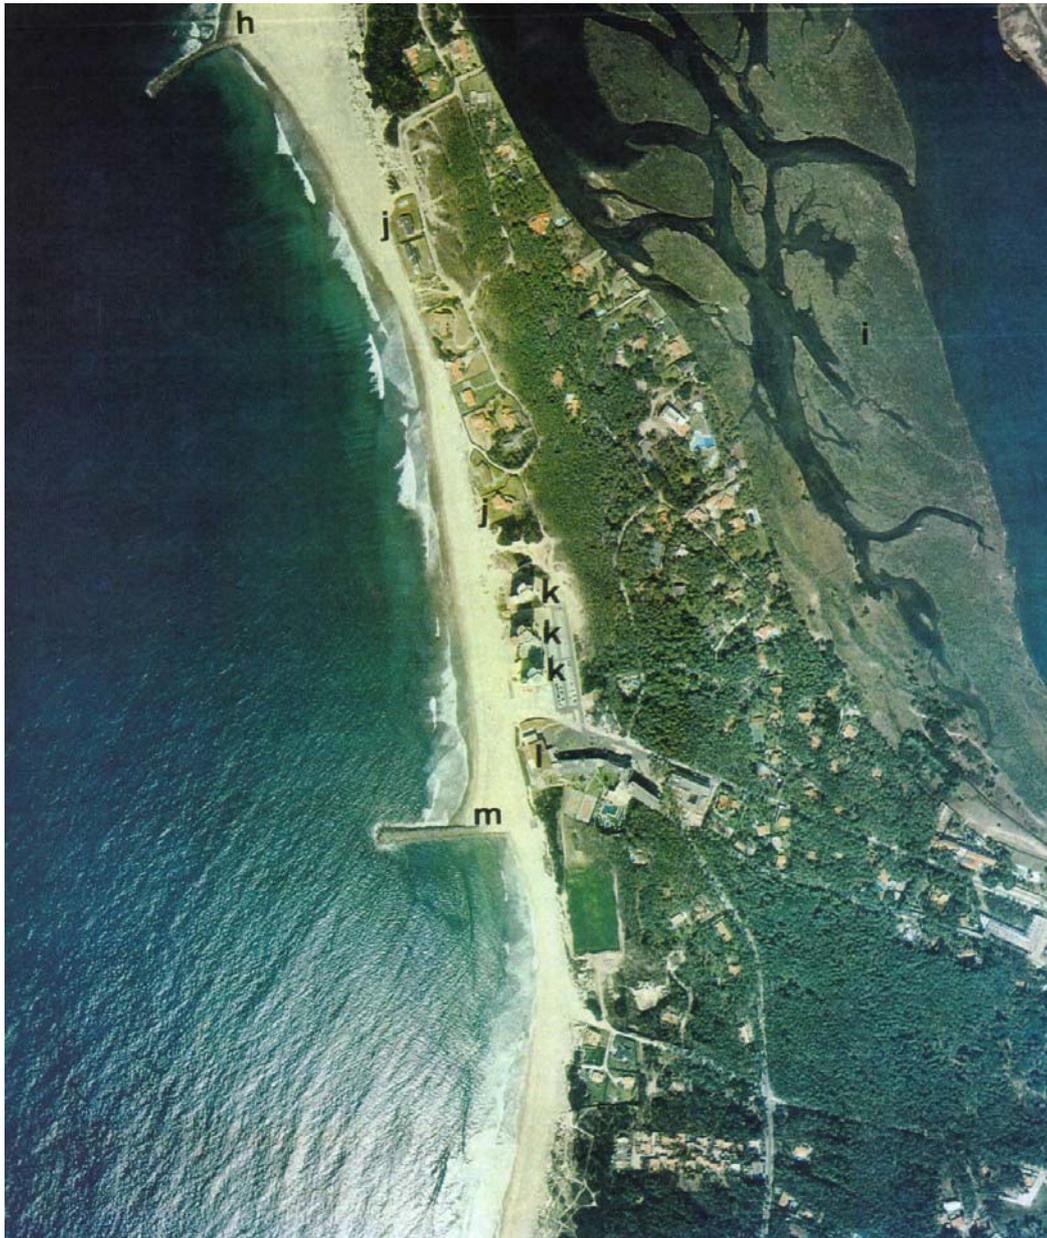
Figure 3. Southern segment of the sand-spit  
(Orto-photograph: INAG, September 17, 2001).

Legend:

- (h) curved groyne;
- (i) wetland;
- (j) houses of *Ofir*;
- (k) *Ofir* towers;
- (l) *Ofir* hotel;
- (m) *Ofir* groyne;

- between the north groyne of *Cávado* and southwards the hotel of *Ofir* (Figures 3 & 6), contrary to the erosion rates of 0.2m/year between 1923 and 1950, a lost of ca. 1m/year has occurred in three decades, between 1950-1980; a new accretion period, related with the construction of a groyne southwards the hotel of *Ofir* was initiated in 1983; by this time, the shoreline growth was about 5m/year however today the shoreline is again experiencing erosion estimated at a lost of ca. 0.8 m/year.

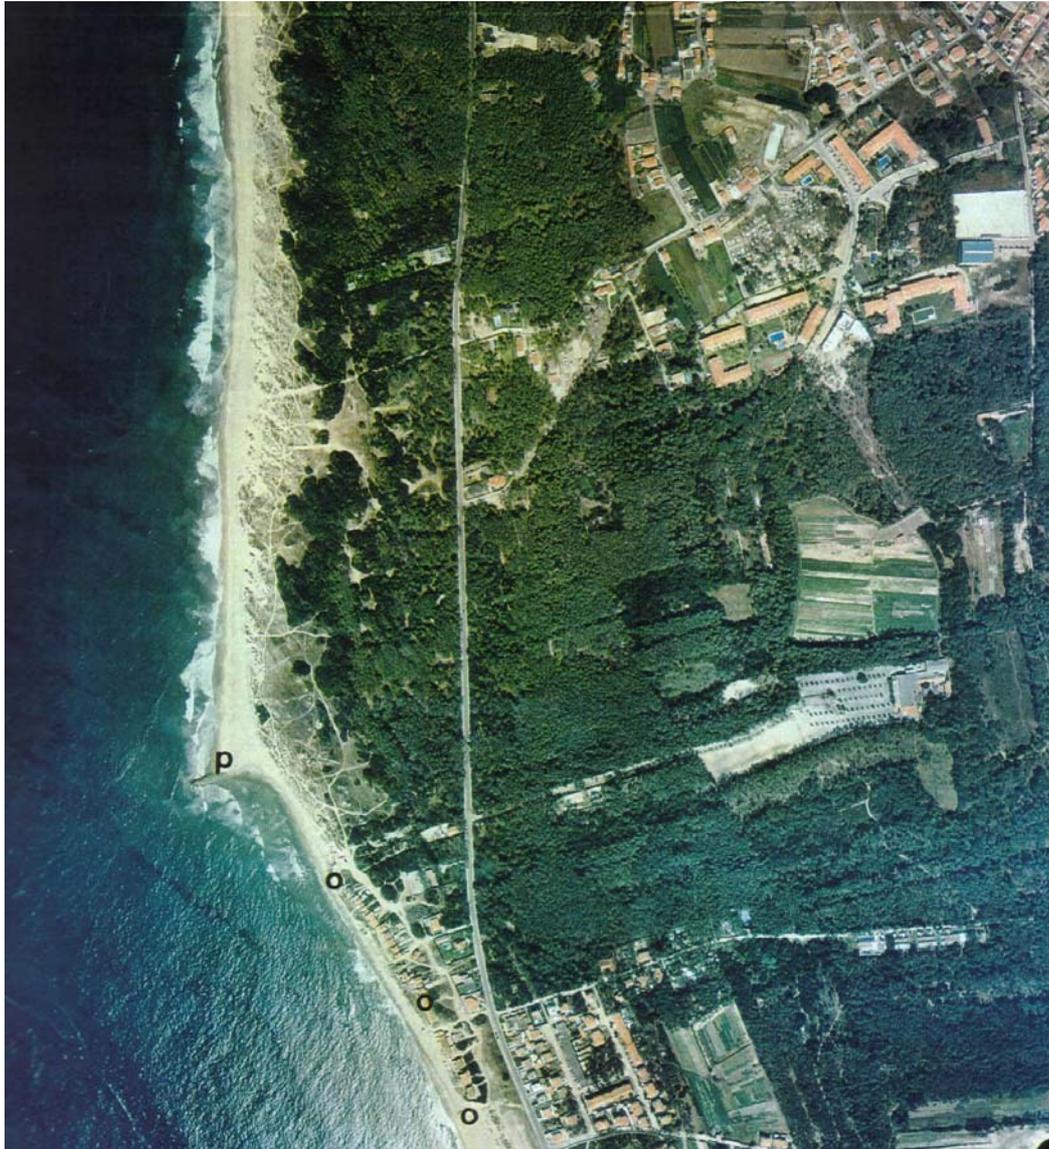
Figure 4. *Pedrinhas* segment  
(Orto-photograph: INAG, September 17, 2001).

Legend:

- (o) *Pedrinhas* village;
- (p) *Pedrinhas* groyne;

→ Pedrinhas groyne, Figure 4;

- in a stretch of 400m length, north and south the *Pedrinhas* groyne (Figure 4), the bathymetric 0m has retreat, in a range of 22 to 44m; the bathymetric +2m has retreat, in a range of 16 to 50m southwards the groyne and progressed in the northern segment; finally, the bathymetric +5m has retreat, in a range of 7 to 42m.
- in a stretch of 700m length, close to the *Ofir* towers (Figures 3 & 6) and southwards the groyne close to Hotel of *Ofir*, there was a generalized retreat of the -5, -2, 0, 2 and +5m bathymetries, with the exception of the +5m which progressed north and immediately south the groyne. Table 1 gives values of bathymetries variation between 1987 and 1994.

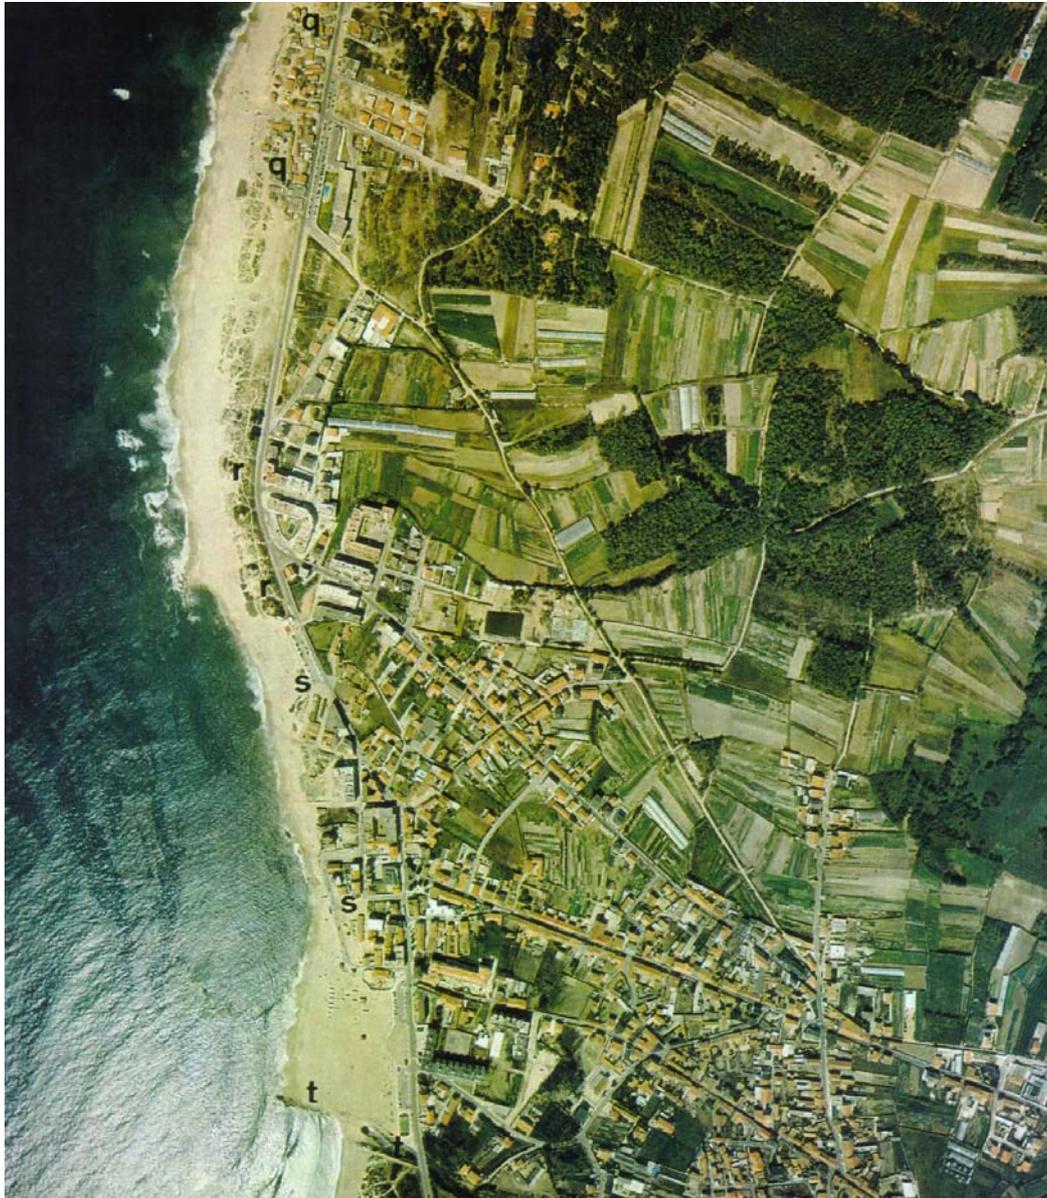
Figure 5. *Cedobem/Apúlia segment*  
(Orto-photograph: INAG, September 17, 2001).

Legend:

- (q) *Cedobem village;*
- (r) *Wind mills;*
- (s) *Apúlia;*
- (t) *Apúlia groyne and small stream.*

→ Apúlia groyne (regularization of the small stream), Figure 5;
