TALLINN (ESTONIA)

1. GENERAL DESCRIPTION OF THE AREA

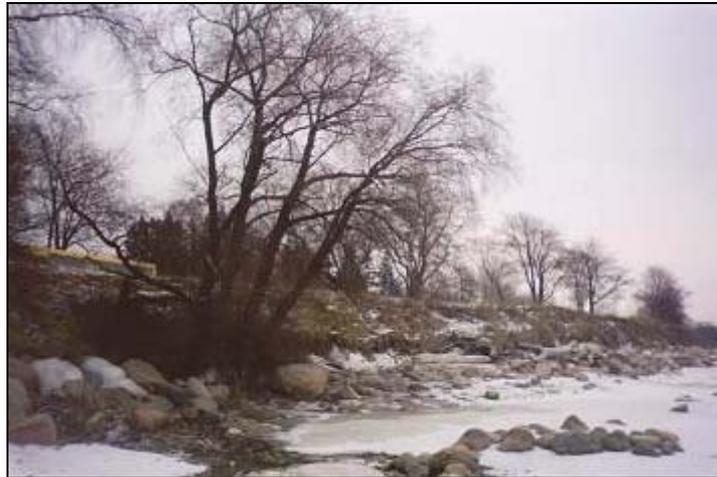
Fig. 3: Eroded moraine bluff at Merivalja – Pirita road. Photo: R. Povilanskas, December 2002.

The formerly inactive low moraine bluff is eroded during extremely severe storm events (Picture 1).

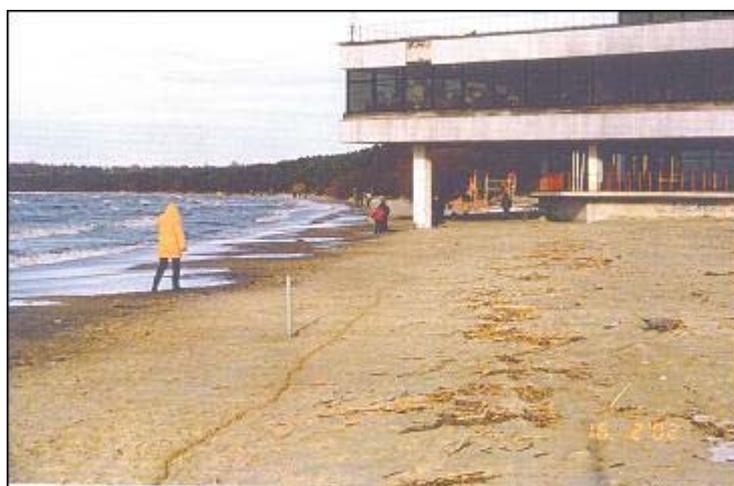
Fig. 4: Recreation facilities on the Pirita beach. Photo: K. Orviku, February 2002.

At the beach nourishment site in Pirita the coastal erosion continues and slightly increases due to increasing storm wave and surge activity and to increasing deficit of sediments. The beach nourishment efforts at Pirita have been relatively effective in the conditions of limited erosion agents. Till the exceptionally strong storm of November 2001 the beach was relatively stable there. Now the renourishment is needed again, as the beach wasn't naturally replenished afterwards. The strengthening of the coast with boulders is relatively effective in the case of an indented and sheltered study area, however latest investigations show, that it should be even more effective if applied in combination with geotextile. The effectiveness of the cliff cutting at Kakumae is still to be examined. So far it had shown resistance to the wave action during the storm of November 2001 although few places at the beach have been washed off.

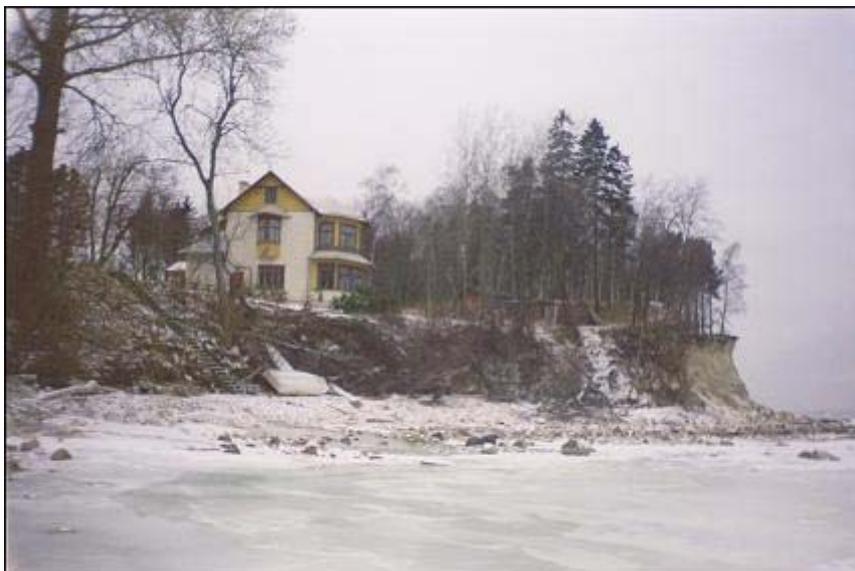
Fig. 5: House threatened by cliff erosion in Kakumae. Photo: R. Povilanskas, December 2002.

Within the study area the increasing erosion currently threatens only the recreational functions of the Pirita beach and the existence of few earlier built houses, which are located too close to the edge of the escarpment (Figure 5). The total capital at risk is ca. 0.4 – 0.6 M. EUR.

The new residential area is located next to the escarpment and might be eventually threatened if erosion increases.

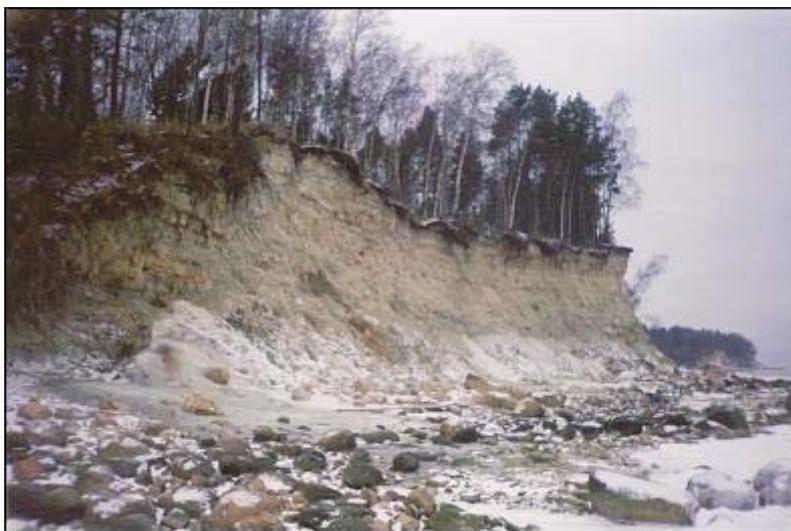
Fig. 6: Eroded sandstone cliff in Kakumae. Photo: R. Povilanskas, December 2002.

Waves erode the sandstone cliff (Picture 4). If the storm wave and surge action increases, the coming decades might witness a more intensive retreat of the shoreline and the cliff edge.

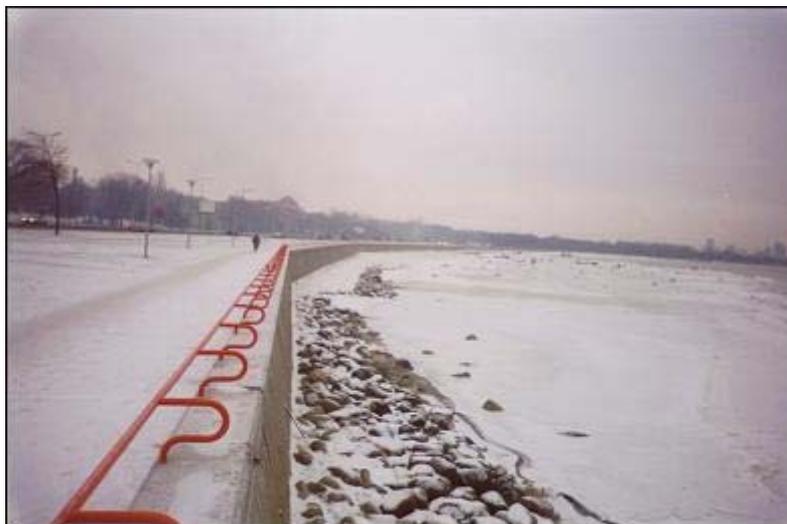
Fig. 7: Coastal seawall along the Tallinn – Pirita road. Photo: R. Povilanskas, December 2002.

Between Tallinn and Pirita a seawall was constructed in late 1970s (Figure 7). The coast along the Pringi-Puunsi road was paved with boulders in 1998 – 2000. Also, there exist plans to introduce geotextile combined with application of boulders in order to defend the threatened coastal road at Tammneeme. At Kakumae near new residence district the strip of sandstone cliff was graded in 2000 for coastal defence purposes (Figure 8).

The length of Tallinn-Pirita seawall is approximately 2,5 km. The length of coastal strips paved with boulders along the Pringi-Puunsi road and the length of the graded sandstone cliff at Kakumae total 1.5 km each.

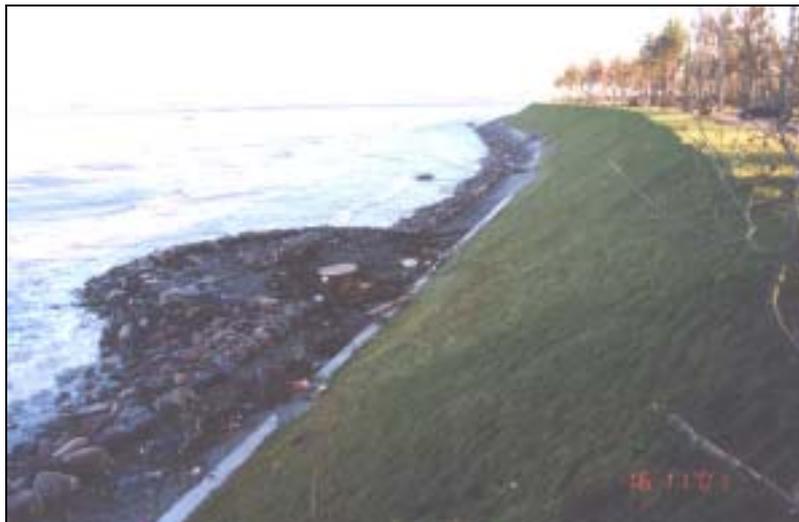
Fig. 8: Graded sandstone cliff at Kakumae. Photo: K. Orviku, November 2001.

The cost of paving the coastal strip with boulders along the Pringi-Puunsi road totals 70 thousand EUR. The grading of sandstone cliff at Kakumae was done by a private real estate company. The costs of works, which have violated routine planning and public endorsement procedures haven't been revealed.
