LAKKOPETRA (GREECE)

1. GENERAL DESCRIPTION OF THE AREA

“Lakopetra Beach” Hotel is situated in the Westside of Patraikos Gulf. Patraikos Gulf is located in the North - Westside of Peloponnese in the West entrance of Korinthiakos Gulf (Canal), which separates Peloponnese from central continental Greece (see figures 1 and 2). The studied coastal area is situated 10km East of the entrance of Patraikos Gulf. The coastal length of the Gulf is 30km. The length of the beach in front of the “Lakopetra Beach” is 300m.

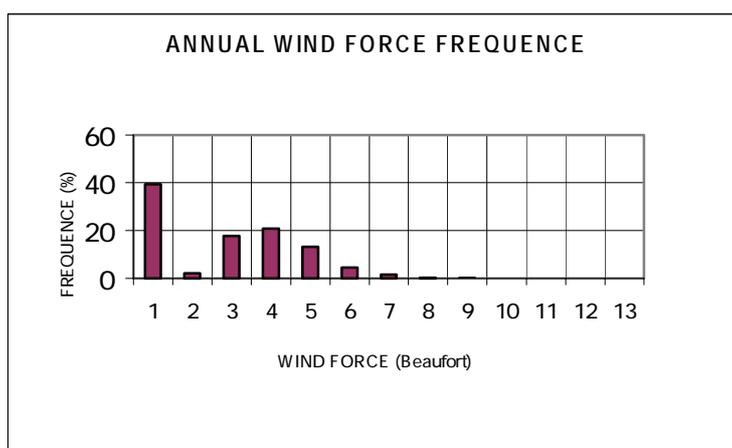
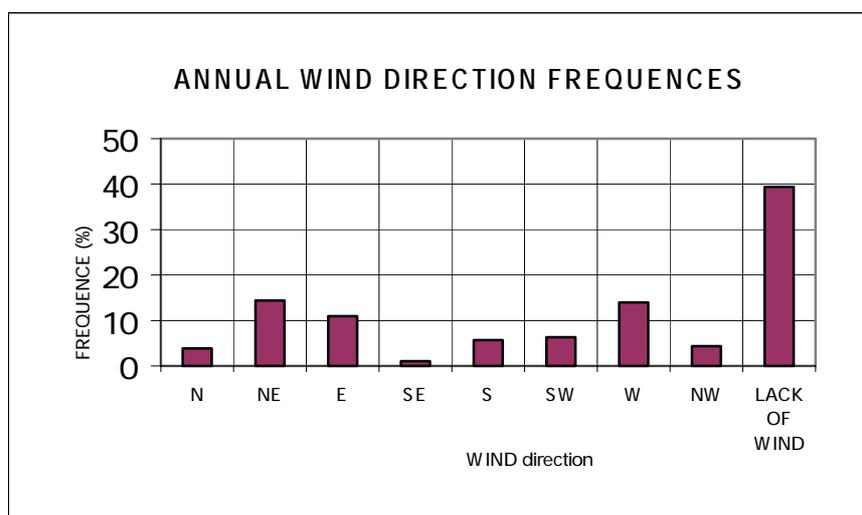
Fig. 3: Annual wind direction & force (data from Araxos airport).

- The most frequent wind forces come from the NE and W directions.
- The maximum wind force reaches the value of 9 Beaufort.
- The most frequent values of winds do not exceed the 4 Beaufort The most frequent wind forces coming from E and NE directions are observed during the winter.
- The most frequent wind forces from W direction are observed during the summer.

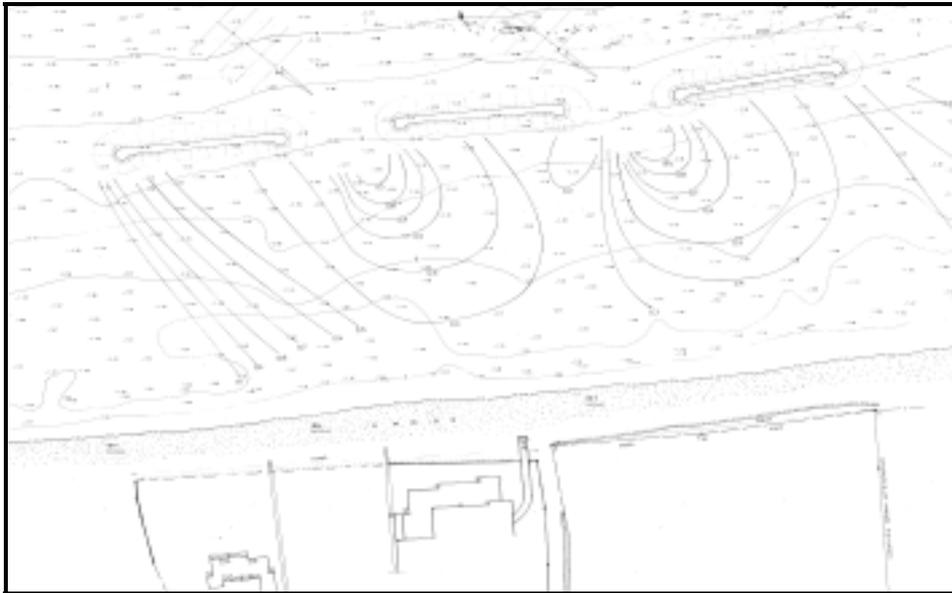
Fig. 4: Survey of the project area.

For more details, see attached drawings (Figures 4 & 5) and photos (Figures 6 to 11) of the project.

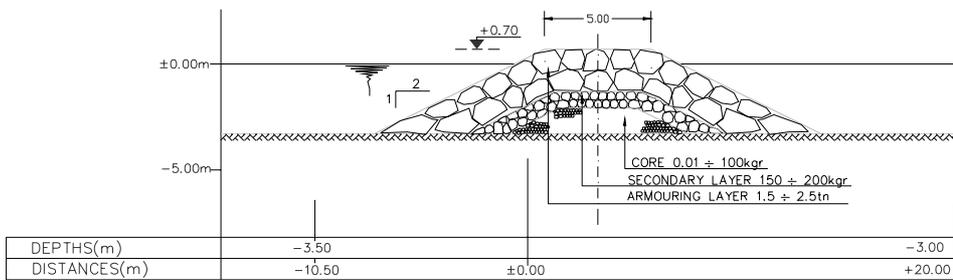
TYPICAL CROSS SECTION

ARMOURING LAYER	$1.5 \div 2.5tn = 34.12m^2$
SECONDARY LAYER	$150 \div 200kgr = 9.00m^2$
CORE	$0.01 \div 100kgr = 9.91m^2$

Fig. 5: Cross section of a detached breakwater.

The cross section details are as follows:

Table 6: Cross section details of the breakwater

Layer	Weight rang	Weight range (Kgr)	Thickness of layer (m)
Armouging	0,75W – 1,25W	1500 - 2500	1,80
Secondary	W/15 – W/10	150 - 200	0,80
Core	W/6000 – W/200	0,01 - 100	-

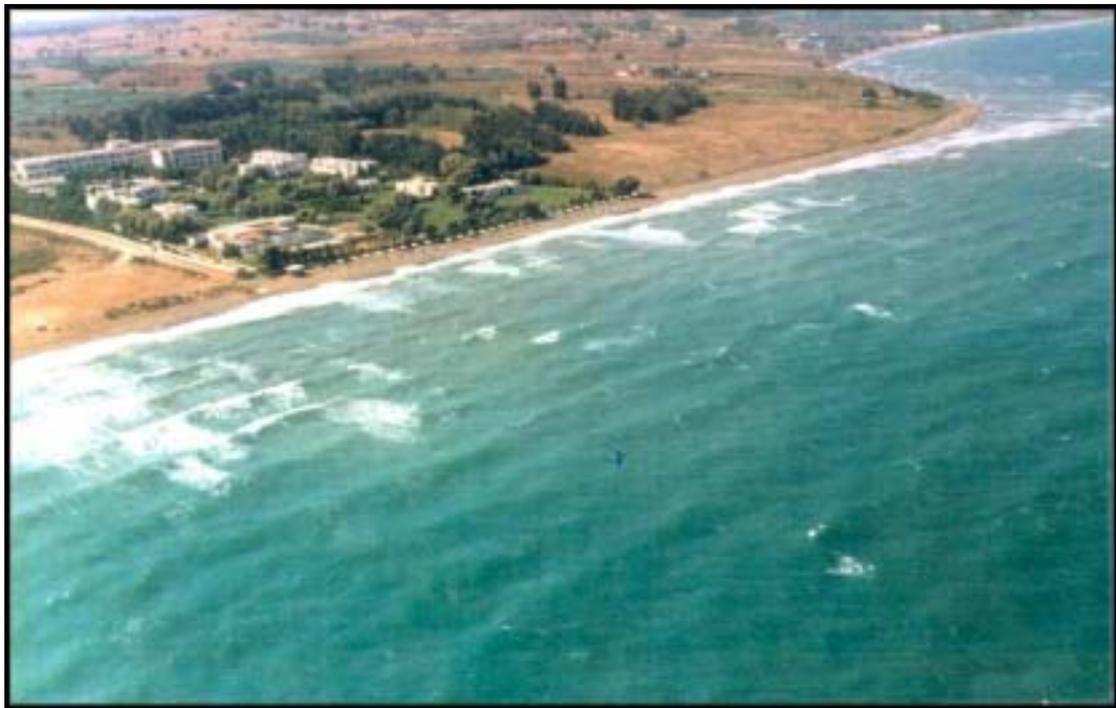
Fig. 6: View of the beach before the construction of the breakwaters.

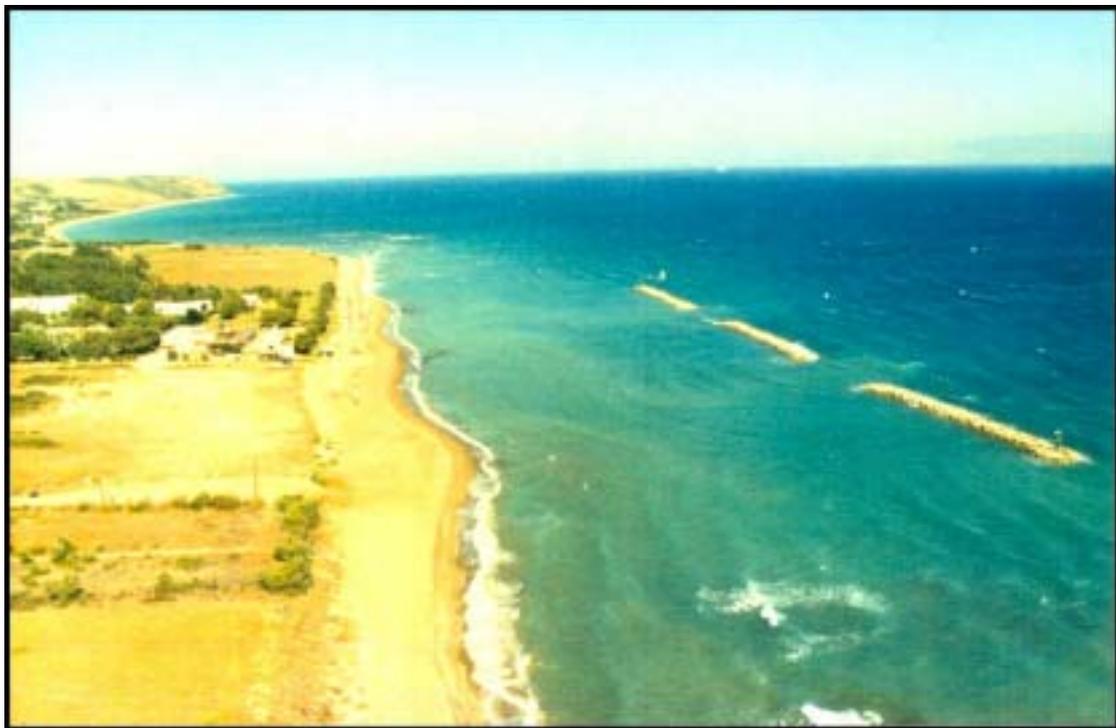
Fig. 7: View of the beach after the construction of the breakwaters.

After the construction of the detached breakwaters the coast erosion stopped, and the erosion mechanism was reversed leading to formation of a new coastal zone due to accretion of sediments in the lee side of the breakwaters.

The coastline response was very impressive. The construction works were finished early in spring just before the beginning of the touristic period and within the same summer the width of the beach was almost doubled. The Hotel manager was very satisfied to offer to his clients an extended sandy beach.

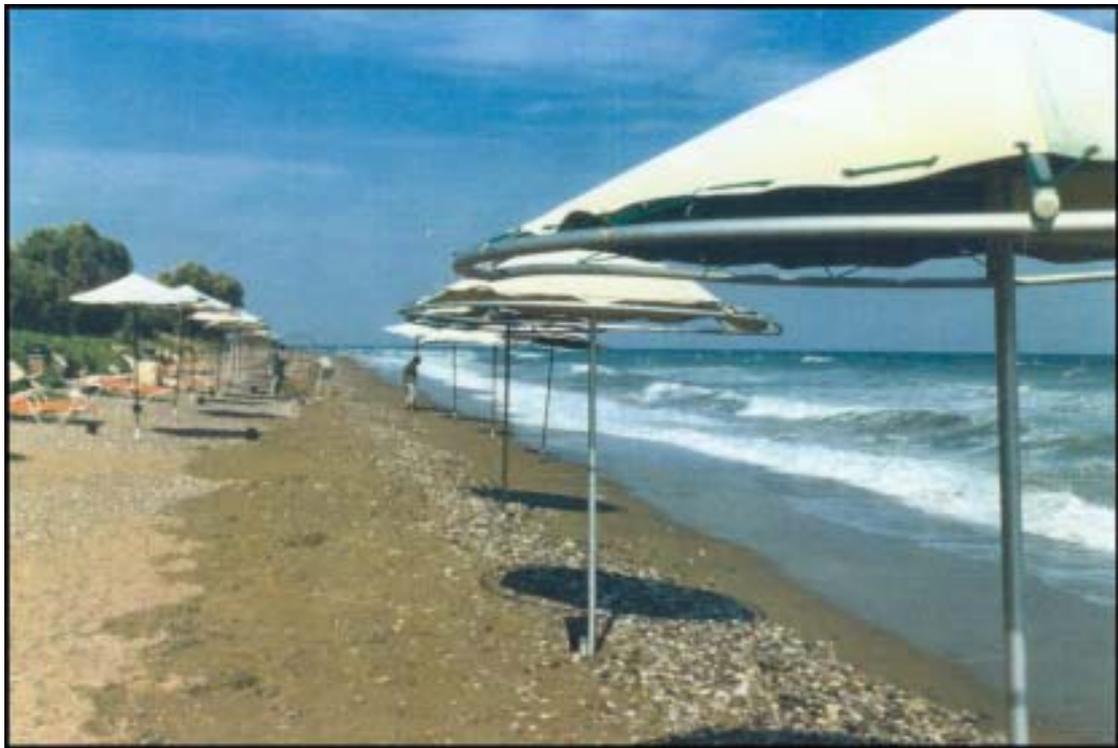
Fig. 8: West view of the beach before the construction of the breakwaters.

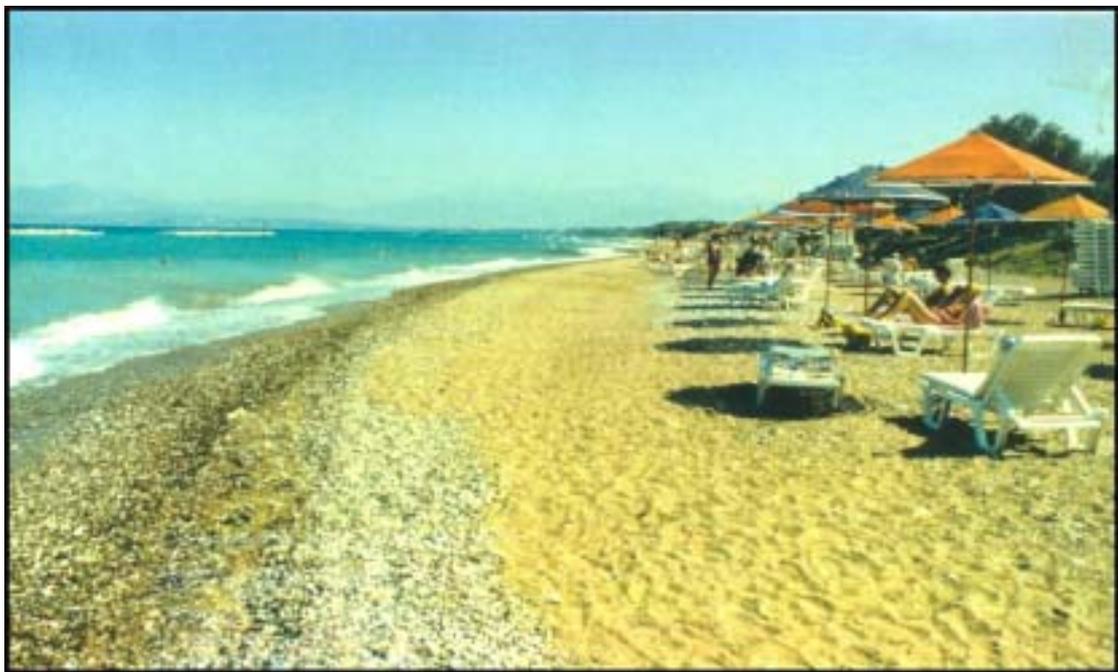
Fig. 9: East view of the beach after the construction of the breakwaters.

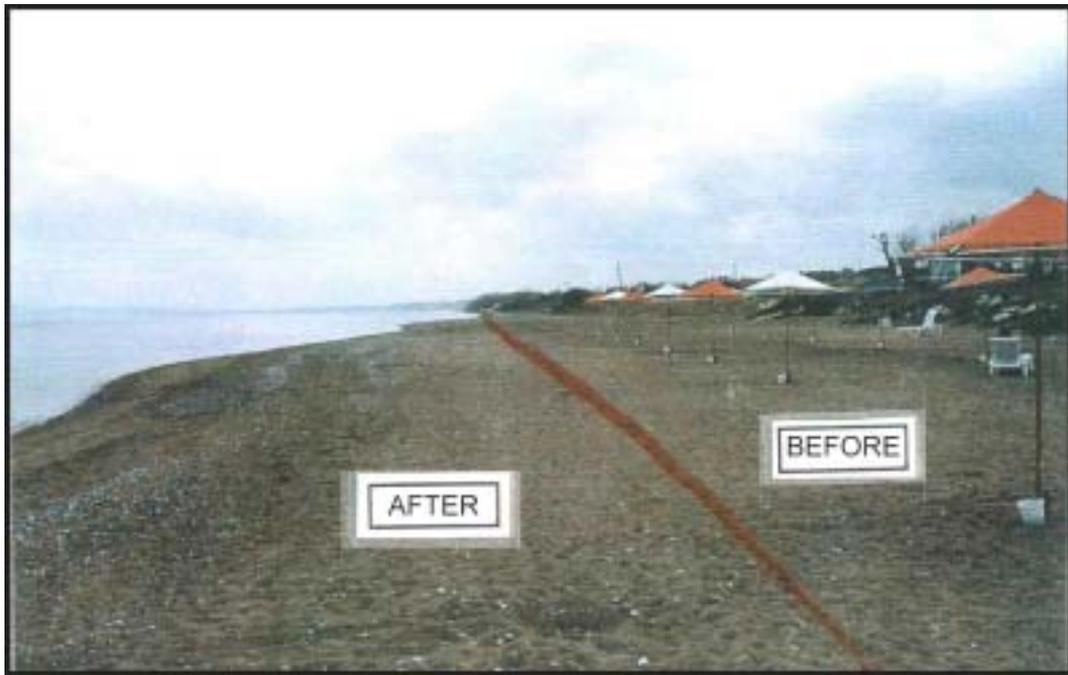
Fig. 10: East view of the beach.

Number of breakwaters	3
Length of each breakwater	68,00 m
Space between breakwaters	43,00 m
Depth of foundation	-3,30 m
Crest elevation	+0,70 m
Distance from the coast	120,00 m

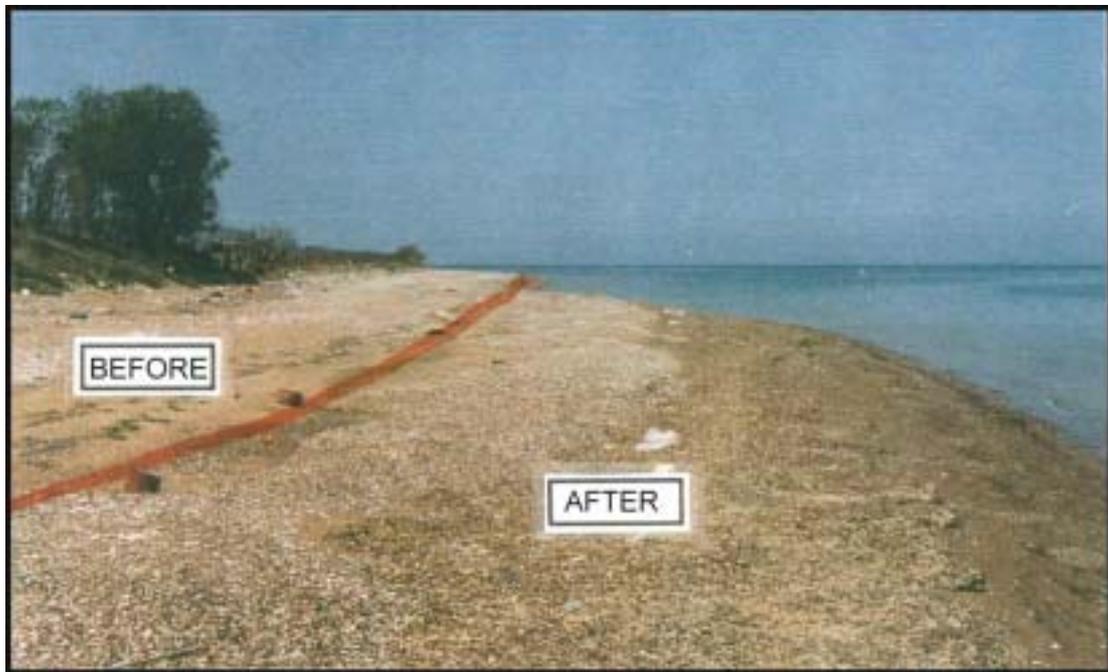
Fig. 11: West view of the beach.
