## ROSSLARE WEXFORD COUNTY (IRELAND)

**DHV group**

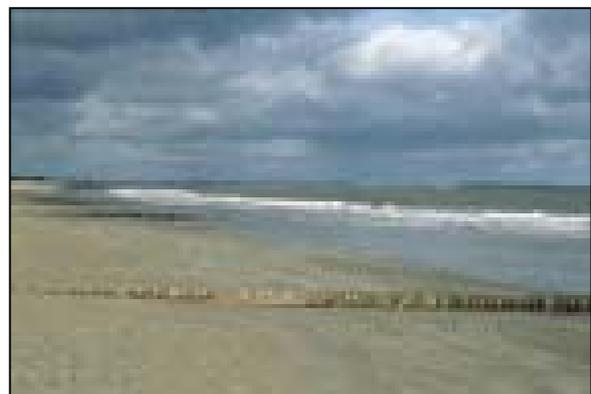
*Fig. 7: Historic timber groynes at Rosslare Strand.*

- Timber groynes, ca. 1957
- Breastworks, ca. 1957
- Rock boulders at toe of glacial cliff over 300 m, successful, 1980s
- Rock armour on dune face, success varying

In 1957 the Office of Public Works began measures to protect the Strand consisting of the construction of timber groynes and breastworks. These works succeeded in slowing down the erosion and holding a fixed position of the shoreline. However the success of the breastworks at reducing coastal recession led to a reduction of sediment quantities available for the natural alongshore drift. This reduction in available sediment along with the vertical nature of the timber groynes and breastworks works, which reflected wave energy, resulted in a lowering of the beach level. Furthermore, the cost of maintenance of the timber groyne system was spiralling in time.
