ROSSNOWLAGH DONEGAL COUNTY (IRELAND)

1.1.2 Geology

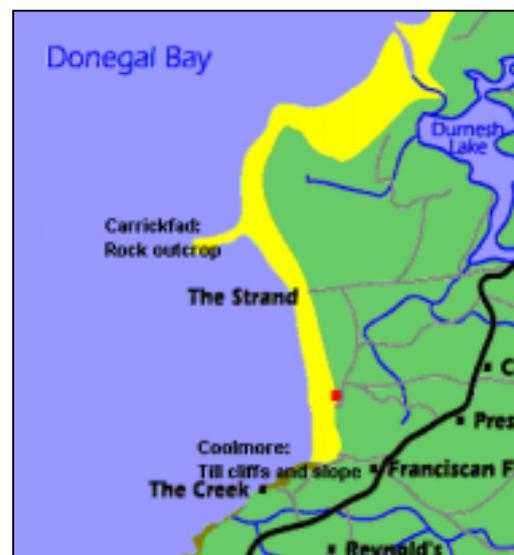
Fig. 3: Overview Rosstown Beach.

The Belalt Strand lies on the eastern coast of Donegal Bay. In the northern end the intertidal rock outcrop of Carrickfad borders the beach (see Figure 3). The beach then extends for over 2 km to the south until it reaches the cliffs at Coolmore in the

south. The beach is backed by till-capped bedrock to the south, sand dunes along the central section and drumlin till to the north.

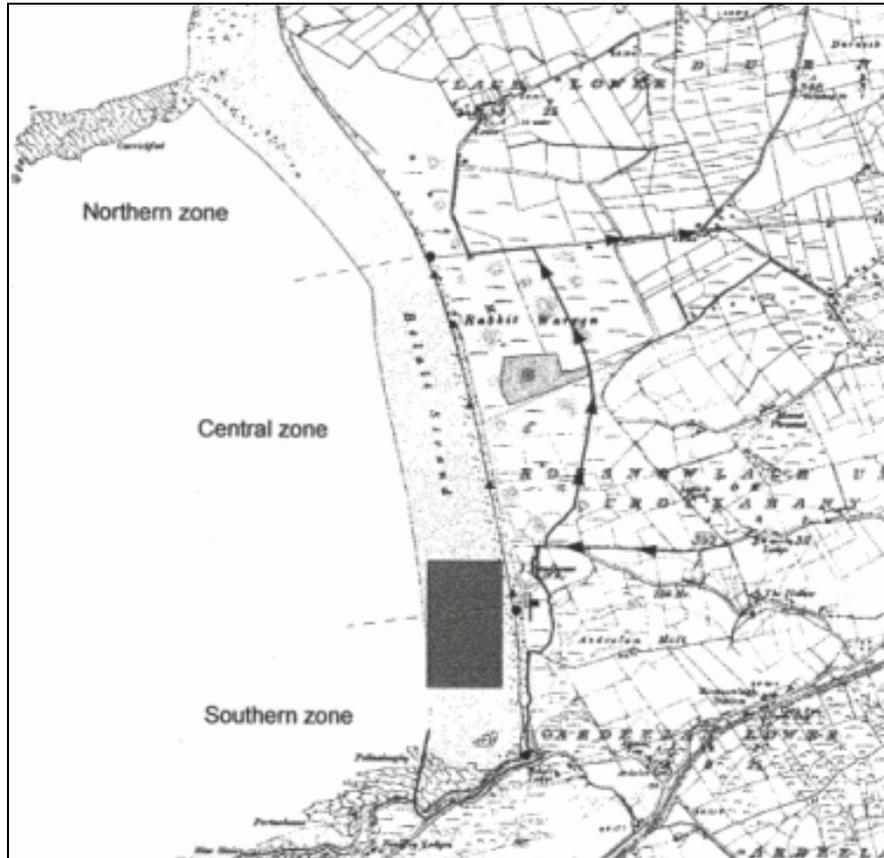
Fig. 4: Detailed view of the case area.

In Figure 4, the Belalt Strand at Rosstownlough is shown in more detail.

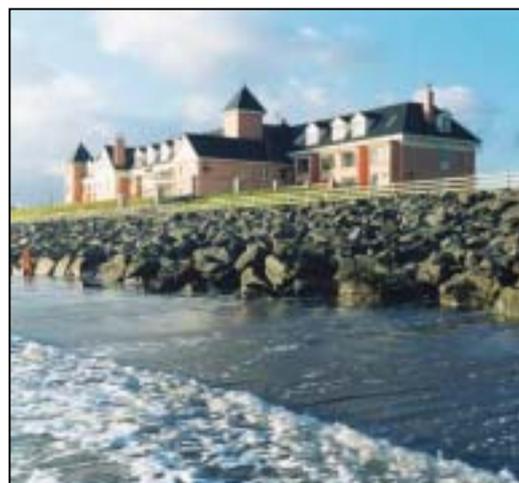
Fig. 6: Armoured section at Sand House Hotel.

Erosion in the central area was highest between 1951 and 1977. Construction of rock armour, which started with armament of the dune front in front of the Sand House Hotel, has stopped erosion at these locations. The rock armour was not placed in one long protection, but in an ad hoc manner over short lengths. Between these armoured sections erosion has continued, giving the dune front a ragged appearance. Between the Sand House Hotel armouring and the Swan Lake caravan park armouring an indentation of 35 m has eroded.

Up until now, armoring has been applied to protect specific locations of the dunes. In 1972 the first stretch of armoring was designed and constructed in front of the Sand House Hotel. Later, private landowners have protected their property by constructing (short) stretches of rock armour on an ad hoc basis. These armour sections are badly designed and constructed. At present, seven sections of rock armour cover a total distance of circa 750 m,

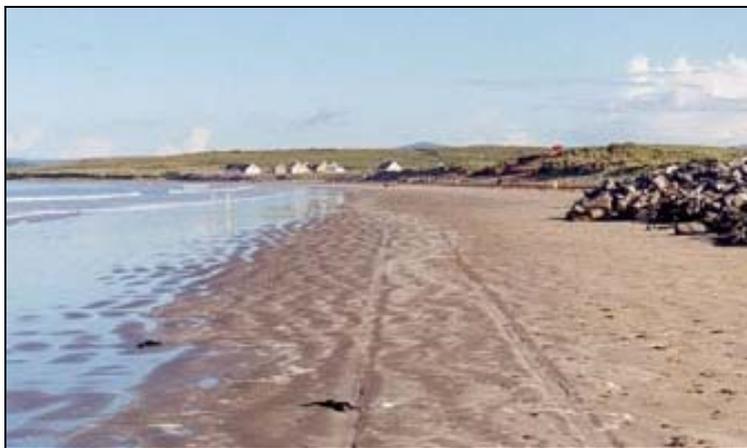
Fig. 7: Present rock revetments at Belalt Strand.

The dune front has been armoured on an ad hoc basis since 1972. At present (that is: by 1999) there are 7 sections of rock armour covering a total distance of 755 m. This means half the sandy shoreline and about 33% of the total coastline of Belalt Strand is protected by rock armour. The longest stretch (225 m) can be found in front of the Sand House Hotel and in general the length of the stretches vary in length between 20 m and 225 m.

this is about half the sandy shoreline. The rock armour has been effective in stopping the erosion at these locations. The unprotected locations however keep retreating. The armouring has also led to increased erosion of the unprotected areas, due to 'end-effects'. As a result the dune front is currently very fragmented, the coastline is composed of linear armour sections alternating with further retreated eroding natural dune sections. These cut deep gaps and hollows in the dune front.
