## WESTERN SCHELDT ESTUARY (THE NETHERLANDS)

## 1. GENERAL DESCRIPTION OF THE AREA

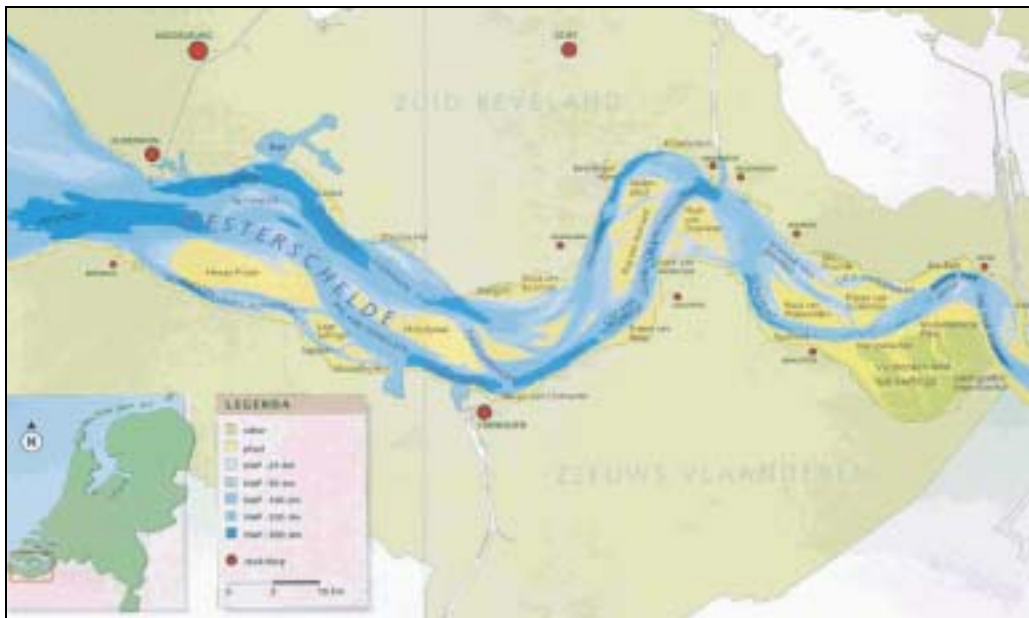
The Western Scheldt exhibits a well-developed system of channels and shoals (see Figure 2). It has a funnel-shaped geometry and covers an area of about 370 km<sup>2</sup>. Its cross-sectional area decreases exponentially from the estuary mouth at Vlissingen to the estuary head near Gent. The width averaged depth decreases from about 15 m at Vlissingen to only

Fig. 2: Overview of the Western Scheldt.

Both natural and human factors have determined the present configuration of the Western Scheldt. In general, the surface area of the estuary has decreased, mainly by land reclamation. Since 1800 about 15.000 ha. of intertidal area has been reclaimed (RIKZ, 1996). Between 1960 and 1990 the area of shallow water zones and intertidal salt marshes and mud flats has decreased with about 3200 ha, partly due to land reclamation and dike reinforcement, but also due to erosion caused by sea level rise, climate change and tidal cycles. Another type of human interference that is of great importance in the Scheldt estuary is dredging. In the beginning of the 1970's and also in the end of the 1990's, the Flemish government deepened and widened the navigation channel to Antwerp. As a result, the yearly amount of maintenance dredging has increased from 4 Mm<sup>3</sup> (1970) via 8-10 Mm<sup>3</sup> (1995) to an expected amount of 14 Mm<sup>3</sup> in 2002. Most of the dredging was done in the eastern part of the estuary (east of Hansweert, see Figure 2).

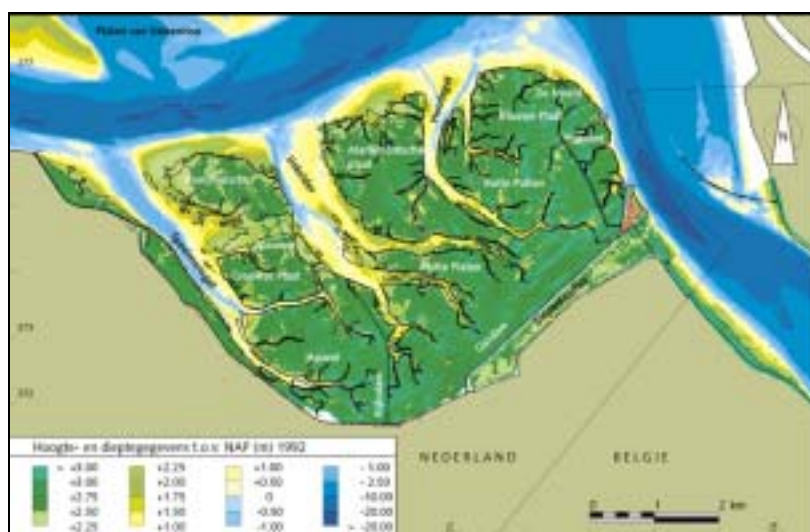
Fig. 4: The 'Verdronken Land van Saeftinghe', near the Belgian border. Depths are given with respect to N.A.P. (Dutch Ordnance Level, approximately equal to the mean water level).

- **Nature conservation:** The Western Scheldt comprises a number of internationally recognized nature reserves, which are important for birds. One of them is the 'Verdronken Land van Saeftinghe', near the Belgian border (see Figure 4), one of the largest brackish water salt marshes in Europe (about 3500 ha.), which has been a Ramsar-site since 1995 ([www.ramsar.org](http://www.ramsar.org)). Yearly, about 400-500 seals are counted.

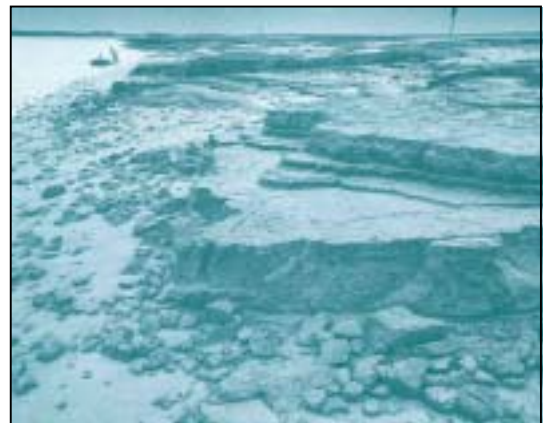
Fig. 6: Local erosion in intertidal area.

Damage to dikes by meandering channels threatens the hinterland.

The locations at which the natural meandering of the channels may cause critical situations by causing damage to the dikes are indicated in Figure 5 and 6. The red lines in the figure indicate a fixation of the main channel by dikes.

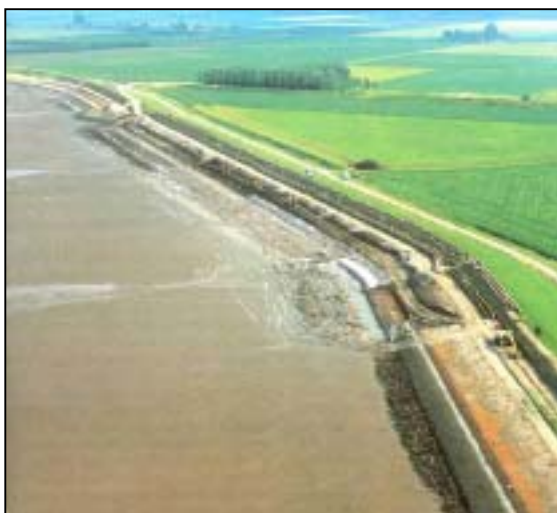
*Fig. 7: dike at Western Scheldt*

The increased propagation of the tidal wave has led to increased high water levels. The dikes are raised to ensure the safety of the hinterland.

At other locations, an attempt is made for the rehabilitation of intertidal salt marshes. Here, plans have been developed for the construction of small piers, with the purpose of creating protected areas where sedimentation of fine sediment is stimulated. Here, a 'move seaward' strategy is adopted (see Figure 7).

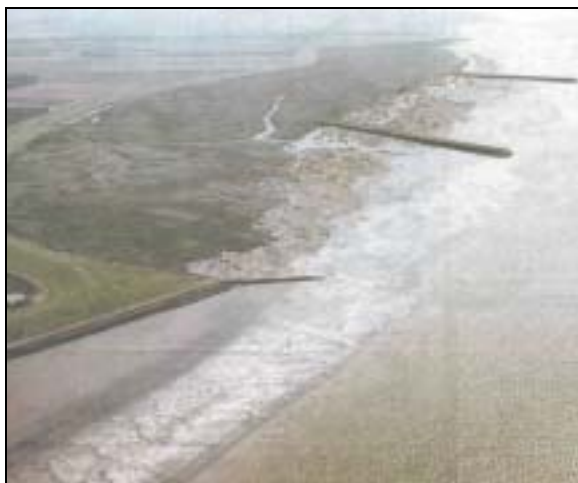
3. Thirdly, intertidal salt marshes are rehabilitated by constructing small piers (pile rows or stones) with the purpose of creating protected areas where sedimentation of fine sediment is stimulated (see Figure 9).

Fig. 9: Protection of eroding salt marsh near Waarde.

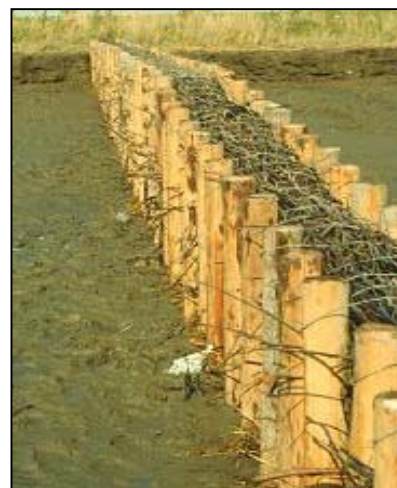
Recently, a project was defined for the protection of the intertidal salt marsh (about 100 ha.) near Waarde (see Figure 10).

Fig. 10: Pier protection of tidal area.
