CASE STUDY

Coastal Protection of the Leirosa Sand Dunes System

Leirosa, Portugal

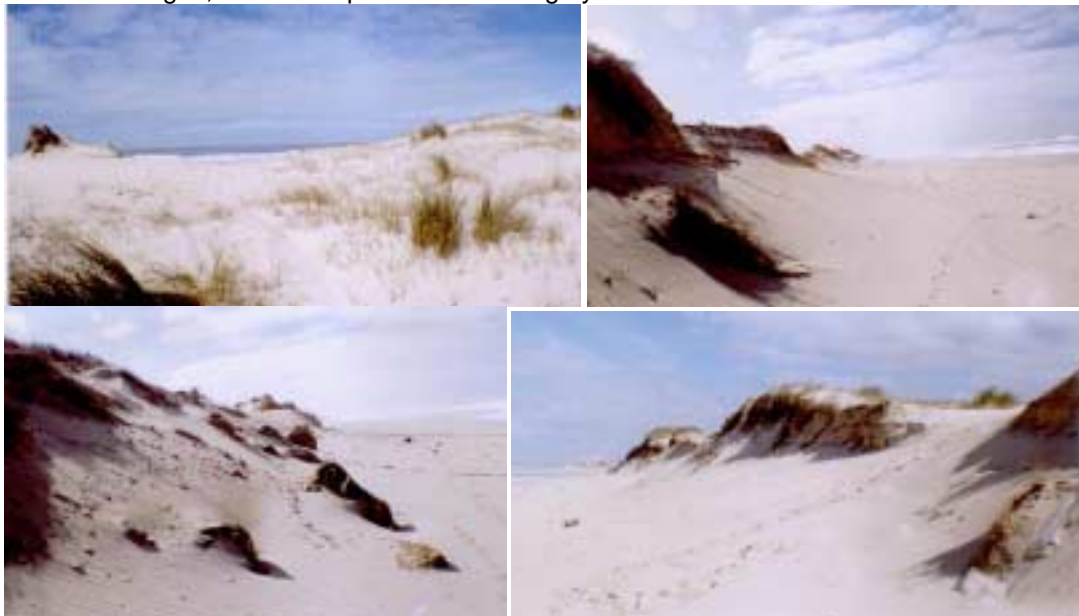
After a couple of years, it was noticed a big change of the protection dune profile and a dramatic regression along the beach, mainly due to the existence of a breakwater located close to 1 km north, which causes the retention of large amounts of sand north-side of it, and a natural increase of erosion problems at the south-side. By the end of 1999 the protection dune was almost broken and flat, and it was decided to look for technical support from specialists to repair such damages, in order to preserve the integrity of the deaeration chamber.

Figure 1 – Leirosa sand dunes system, February 2000

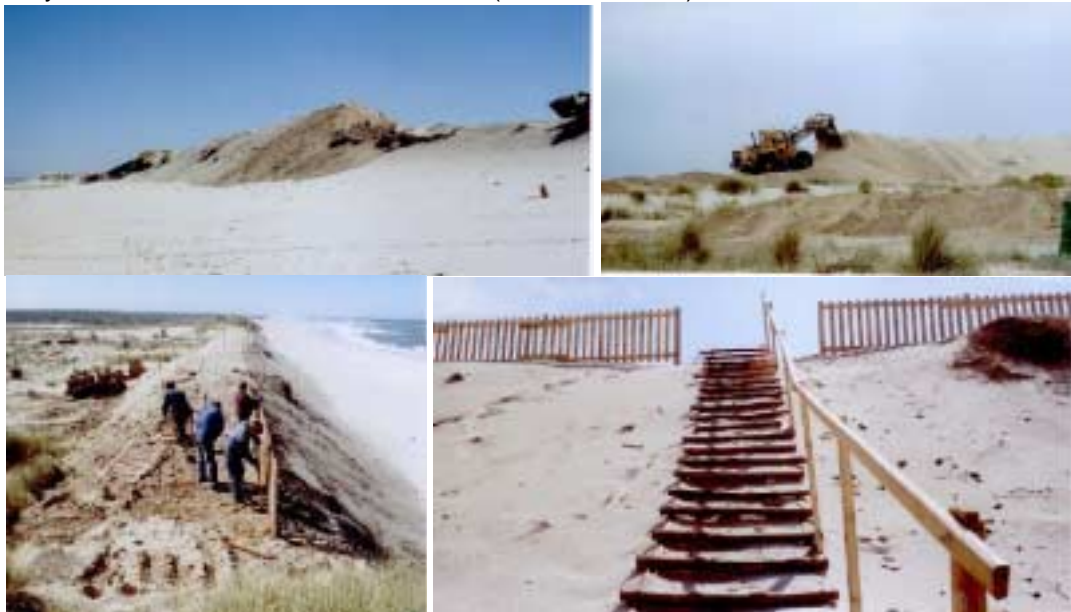
shorter time, known as AIDS – Artificially Inseminated Dune System (Carter, 1995). For three weeks sand was brought from a close inland site and the foredune of the Leirosa system was rebuilt in an extension of about 200 m, in front of the deaeration chamber of the outfall pipe. The sand used in the reconstruction of the dune was very similar to the existing on the dunes in terms of texture and nutrients' content.

To assist the erosion control, but essentially to avoid traffic and people crossing in the recently shaped dune, a wooden fence was built around the restored area. A walkover with stairs was also constructed to allow people to access the beach. The fence was made from pine planks with 1m height and 8 cm width, placed 8 cm apart from each other to create the 50% porosity, which is advised in these situations (Dewhurst, 1999).

Figure 2 – Leirosa sand dunes system, March 2000

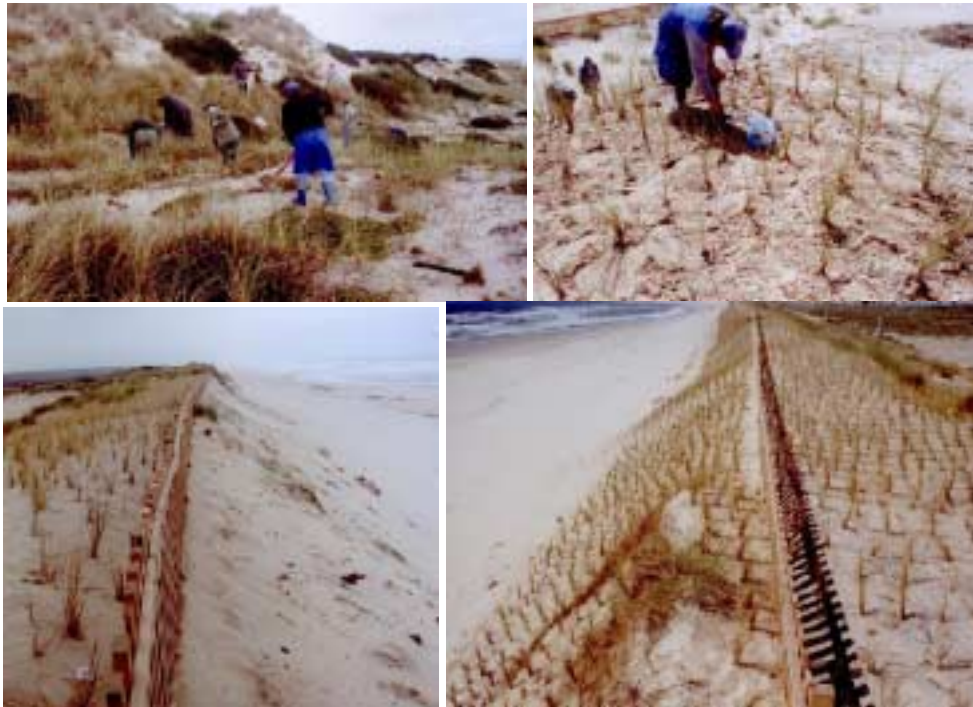
Plants were collected in the morning and stored in large plastic bags with wet sand in the bottom. The transplant in the Leirosa dune was done every afternoon, so that plants wouldn't stay overnight. With small shovels, holes of about 20 cm depth were made and, after adding a very small amount of fertilizer, one or two shoots of *Ammophila arenaria*, were dibbled. Since the slope of the dune was rather steep, a close pattern of 50 cm in diagonal grid was chosen for the revegetation. The transplants were only placed where no other vegetation previously existed. No more than 100 Kg/ha of the slower released grain fertilizer "Osmocote" was used, as most appropriate in these works (Seliskar, 1995).

Figure 3 – Leirosa sand dunes system, April and May 2000

Revegetation started in the last week of April and went on for 5 weeks. Even though the best time of the year to do this work is usually the beginning of the Autumn or Spring, as factors like temperature and humidity have strong influence to the success of it, and the Spring of 2000 was characterized by heavy rain in March and April, which made the soil rather humid, a great advantage to the transplants' adaptation. In the Leirosa dune system the combined revegetation of adjacent areas was also performed, in an attempt to recover the complete system.

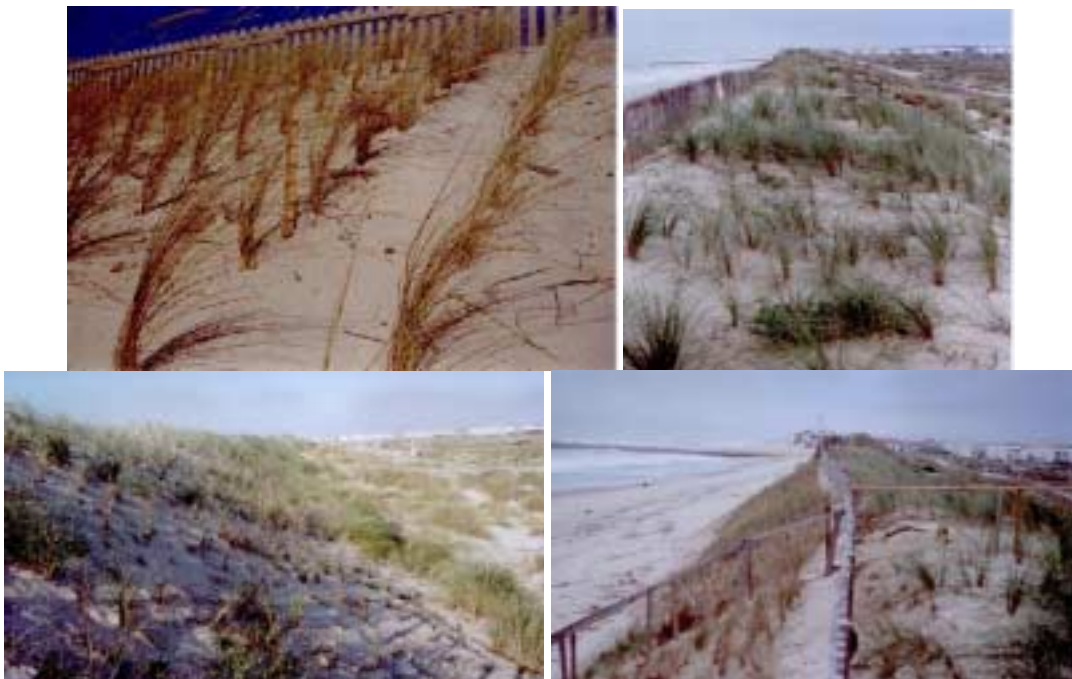
A total of 23250 transplants of *A. arenaria* were planted in Leirosa, 17200 in the continental side and the remainder in the oceanic side. After 4 months, a survival rate of 40% was observed, which can be considered a significant high percentage (Dewurhst, 1999). During summer months a decrease of the number of green plants was verified, most probably due to the hot weather, as in September it happens that such number began to raise, indicating that plants were not dead but just dried up due to transplant and weather conditions.

Although the transplantation occurred in April and May, many of the plants brought to the Leirosa dune were already starting to flower and others started later in that same year, reaching 63.5% and 50.0% in the oceanic and continental sides, respectively. The reconstruction of the foredune allowed a stabilized ecosystem in the back, favoured by the almost inexistent sand mobility. A similar situation did not occur in the oceanic side, where a significant sand accumulation was found during the first phase of the monitoring programme.

Figure 4 – Leirosa sand dunes system, from May to September 2000

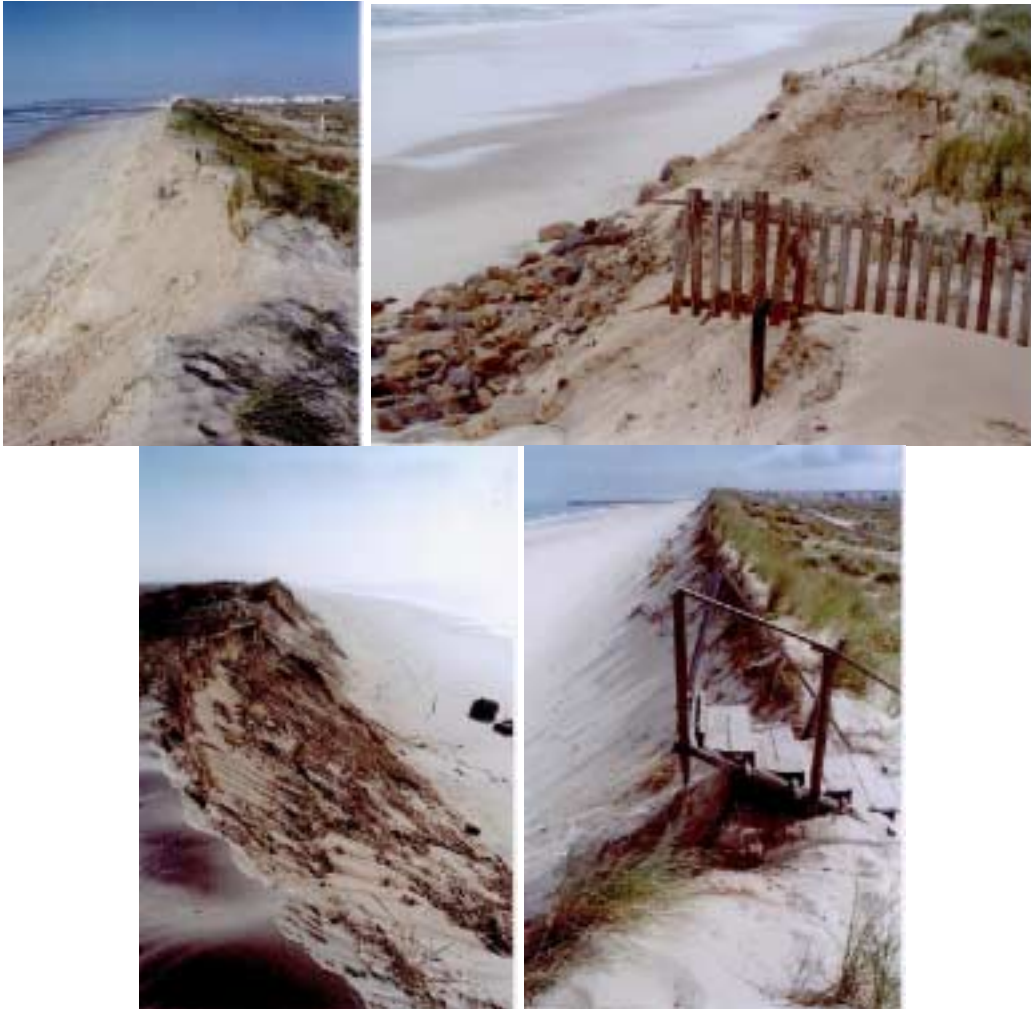
The winter of 2000/2001 was particularly severe, with strong wind and uncommon heavy precipitation, causing huge damages in the Baixo Mondego region and also on the coast. Most of the coastal region was affected, although the effects were largely seen at the south of the breakwater of the Leirosa village, an area already facing strong erosion problems. In February 2001, the oceanic side of the rehabilitated sand dune of Leirosa was destroyed. All the vegetation transplants from that side were lost, and an enormous amount of sand was taken by the sea. The fence placed on the top of the foredune also disappeared. The continental side was already well stabilized and did not suffer with the storm.

Figure 5 – Leirosa sand dunes system, February and March 2001

The industries involved in this project have decided to pursue the monitoring plan in March 2001, after the partial destruction of the foredune in February.

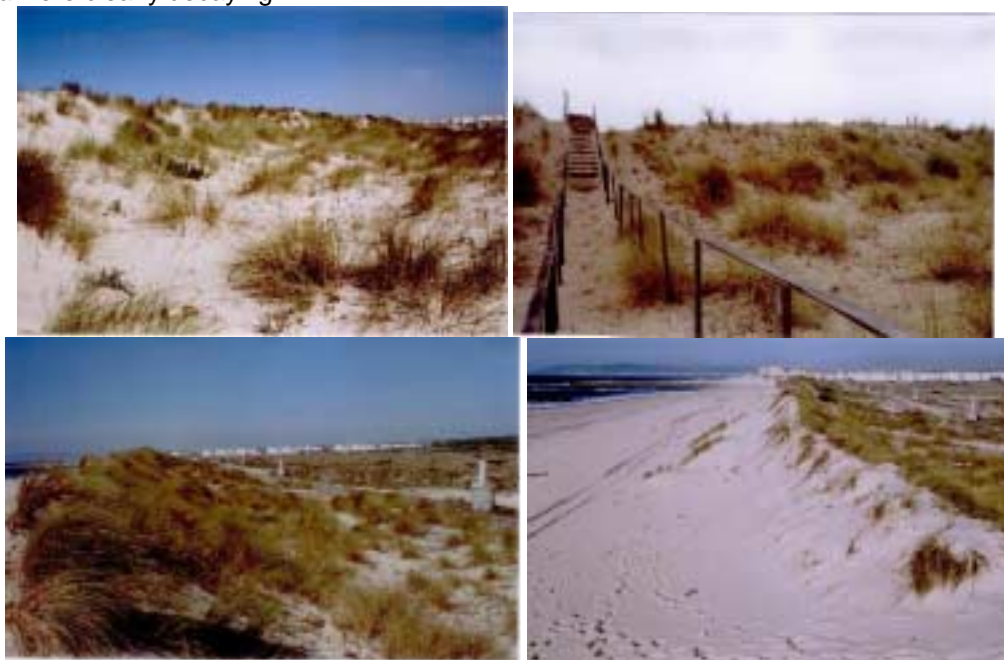
In the summer of the second year of the monitoring plan, seeds from the most representative species were collected from the surrounding area of the rehabilitated dune, and in the spring of 2002 they were sown in places where plant cover was smaller, and where the transplants of *A. arenaria* were clearly decaying.

Figure 7 – Leirosa sand dune system, from March 2001 to January 2005

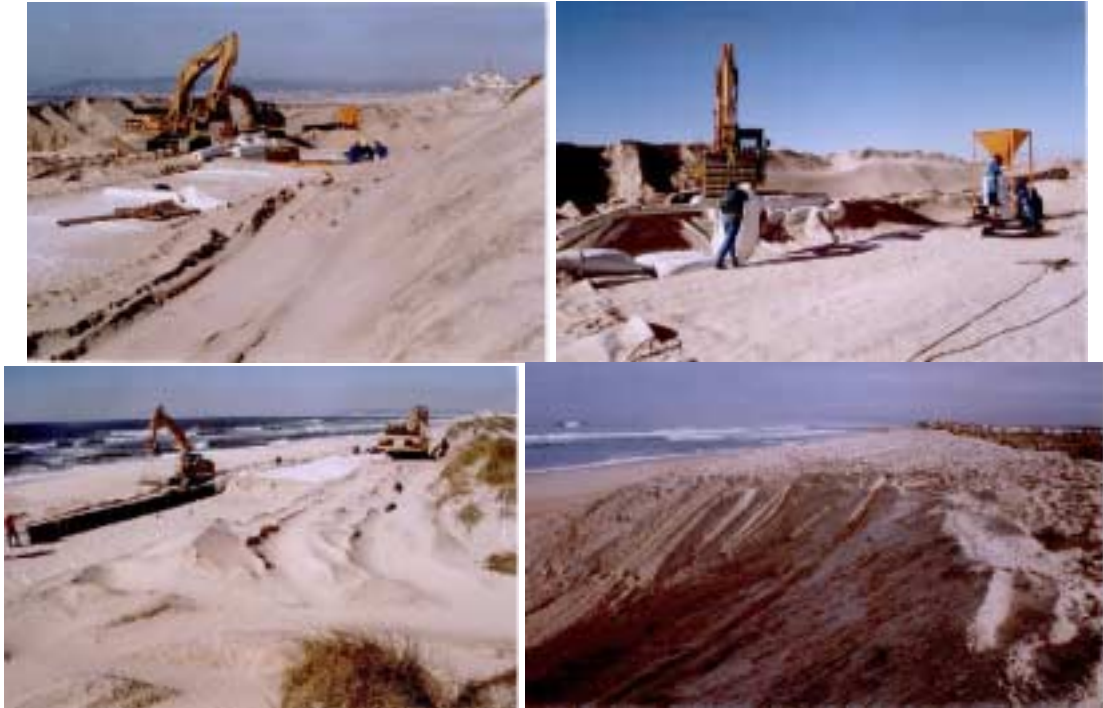
In February 2005, after analysing several proposals of dune rehabilitation by soft and hard engineering, a new intervention in the Leirosa sand dune system was conducted. The decision was based upon the potential efficiency of the technical solution selected, but also costs involved and time required to implement it. Geosynthetic containers filled with sand are playing more and more a relevant role, all around the world, in the construction of coastal and marine structures. Traditional construction techniques using rock, concrete and steel are being increasingly challenged by alternatives offered by geosynthetic forms for revetments, scour protection, groynes, berms, artificial reefs, reclamation and dune stabilization, to name but a few uses. Furthermore, improvements in materials, design and construction methods for such structures are enhancing and diversifying the range of possibilities and applications (Antunes do Carmo *et al.*, 2006). Geotextiles have been successfully used in hydraulic engineering and more recently also in the construction of artificial dunes and stabilisation of beach nourishment measurements. It is shown that the use of geotextiles can be as effective as any so called “hard engineering protection”, with the advantage of being adaptable to the morphology of the dune system, and using locally available sand (Bleck *et al.*, 2003).

In the Leirosa system the application of geotextiles occurred in a dune extension of 120 m along the coast. A defence was created on the front bottom of the dune, at the +2.0 level (hydrographic zero) with sand containers about 6.40 m long, 3.20 m width and 0.825 m height, placed in a pyramidal position parallel to the coastline. The protection barrier was constructed to the height of 8 m by several layers of sand involved in geotextiles, a so called “wrap around technique”, which encapsulates the sand and offers a high installation speed. The upper layer has a geotextile revetment in all the area, with about 8.60 m length, 4.30 m width and 1.10 m height, followed by a 1.0 m layer of sand where dune vegetation is planted, turning this area in an attractive and safe coastal dune system.

Figure 9 – Leirosa sand dunes system, February and March 2005

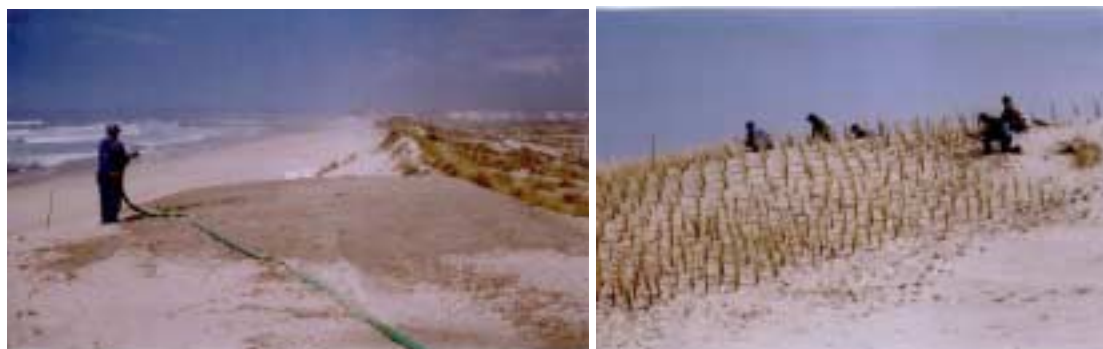
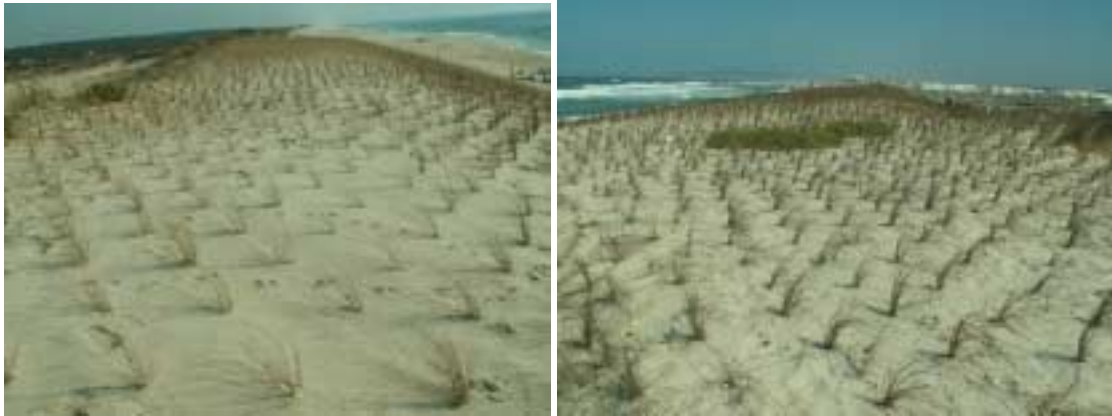
On the top of the geotextiles, a 1 m layer of sand was deposited, and revegetation of the dune was performed with *Ammophila arenaria* transplants. The procedure was in all aspects similar to what have been done in 2001, except for watering.

The revegetation work occurred in an area of 3000 m², and it was conducted by four experience gardeners during three weeks. It started in March/April to allow the complex root and rhizome system of *A. arenaria* to better develop until the beginning of the next winter period. Although it is not very common and necessary to water the dune systems when revegetation works are performed, some irrigation was included this time due to the very dry winter of 2004/05. A container with capacity for 4000 L was used to humidify the sand before transplantation, in the beginning of every working week.

Figure 10 – Leirosa sand dunes system, from March to October 2005

The restored dune was delimited by a previous dune system where some other endemic plants were already growing. In only six months eleven plant species colonized an area where only *Ammophila arenaria* was planted: *Artemisia maritima*, *Calystegia soldanella*, *Crucianella maritime*, *Pancratium maritimum*, *Elymus farctus*, *Medicago marina*, *Silene littorea*, *Eryngium maritimum*, *Polygonum maritimum* and *Euphorbia paralias*. To monitor sand mobility 24 graduated wooden poles were distributed along the restored dune system in transects along the top back, top front and base of the dune. After six months some distinctions could be noticed between the three defined zones, with little or no mobility in the top of the dune and accumulations of about 4 to 6 cm of sand on the base of the dune.

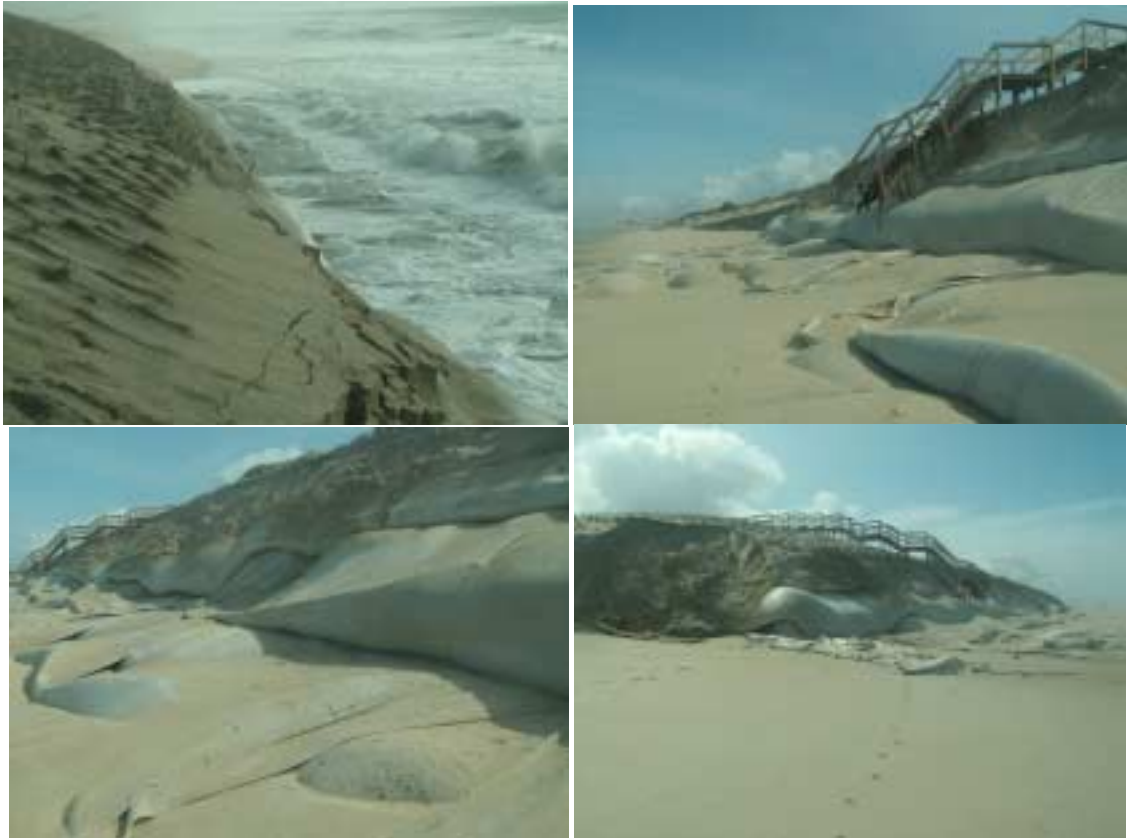
High tides of March and April 2006 have partially damaged the geotextile dune structure. The hydrodynamic forces affected the dune, leading to an opening of the geotextile layers in some parts of the three bottom layers. The opened areas allowed an outflow of the sand fill material which further led to a partial collapse of the dune structure and settlements of the upper 5 layers. Since no failure was detected on the used geotextile, the probable cause was the inappropriate seal of the geotextiles layers, which was partially done in conditions of high humidity.

Figure 11 – Leirosa sand dunes system, March and April 2006

The next step will be the rehabilitation of the geotextile reinforced sand dune in the areas where the encapsulated sand layers have partially opened up. A proposal of rehabilitation with large geotextiles tubes, which are prefabricated to avoid failure of the joints, filled with a suspension of sand and water and placed at the bottom of the existing structure as toe protection, is being analysed.
