Environmental risk assessment; a case study of the Colhuw Beach revetment on the Glamorgan Heritage Coast, Wales

Abstract. A newly constructed coastal revetment at Colhuw Beach in the Glamorgan Heritage Coast, Wales, UK, was analysed using a recently developed environmental risk assessment package (ERA). Conflict with Heritage Coast conservation objectives is apparent and the act of building such a structure is questioned for a location where maintenance of *natural* beauty is an axiom of the coastal management philosophy. The likelihood of revetment related environmental consequences of significant magnitude was analysed using estimated probability values derived from Bayesian theory. The damaging impact of the structure on the natural environment is out of all proportion to the level of storm protection afforded to the site. Analyses, such as carried out via ERA, would have shown planners, engineers and environmentalists, the inadequacies of such an investment and management strategy. The ERA approach can help to introduce greater clarity and consistency into decision making processes.

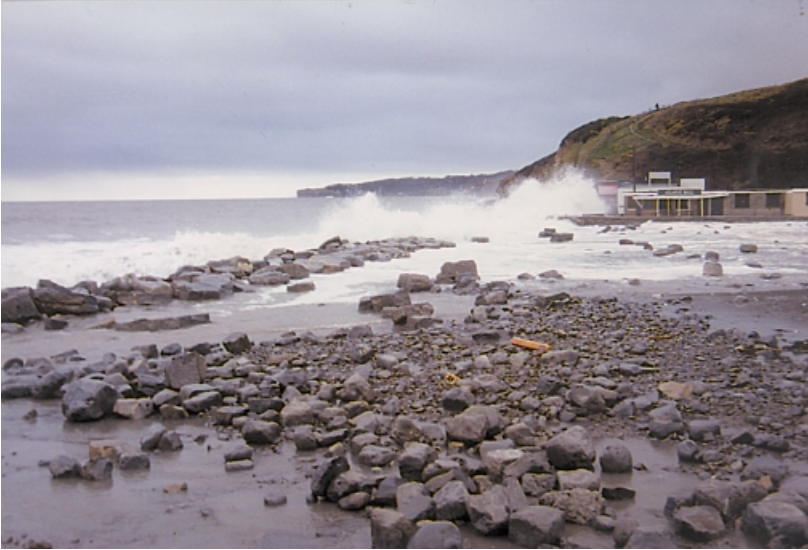
Fig. 3. Storm overwash, Colhuw Beach February 1990.

These strategies have had very limited success and the problem of coastal protection and maintenance of visitor facilities was brought to a halt in January/February 1990 with the occurrence of the most destructive of recent storms. Southwest, onshore wind velocities reached 140km and a storm surge of 3.1m was recorded. This event damaged the existing sea wall on the western side of the upper beach, destroyed the lifeguard station located immediately inland and undermined the foundations of the car park. It also cast tonnes of storm beach debris onto the car park surface, (Fig. 3). The car park and buildings were some 7m above OD. This is 1m above mean high water springs but, as described above, wave run-up is sufficiently strong to cause erosion at elevations > 3 m above this height.

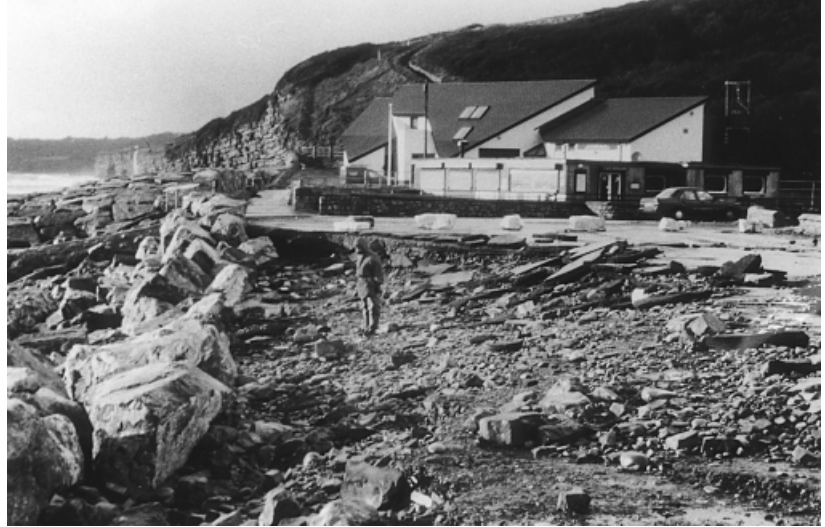
Fig. 5. View westwards at Colhuw showing the November 1996 storm damage.

constructed along the western edge of the upper beach and the lifeguard station rebuilt at a combined cost of 750000 GBP. The structures were placed on almost the identical locations of the sea wall and lifeguard station affected by the 1990 storm. The revetment is large scale within the context of the local environment, measuring some 80m in length, 20m in width and 6m in height. It is built with 7 tonne, roughly rectangular, Carboniferous limestone blocks (Figs. 2 and 4). It extends from the western cliff edge and covers approximately half the beach width. However, in November 1996, just at the point of completion of the project, an onshore south-westerly gale at high tide caused damage to the new lifeguard building, severe downdrift upper beach erosion and undermining of the foundations of the eastern side of the car park, (Figs. 5 and 6).
