## CASE STUDY

### *ESPINHO - 100 years of Beach Protection*

*Espinho, Aveiro, Portugal*

*Beach Protection*

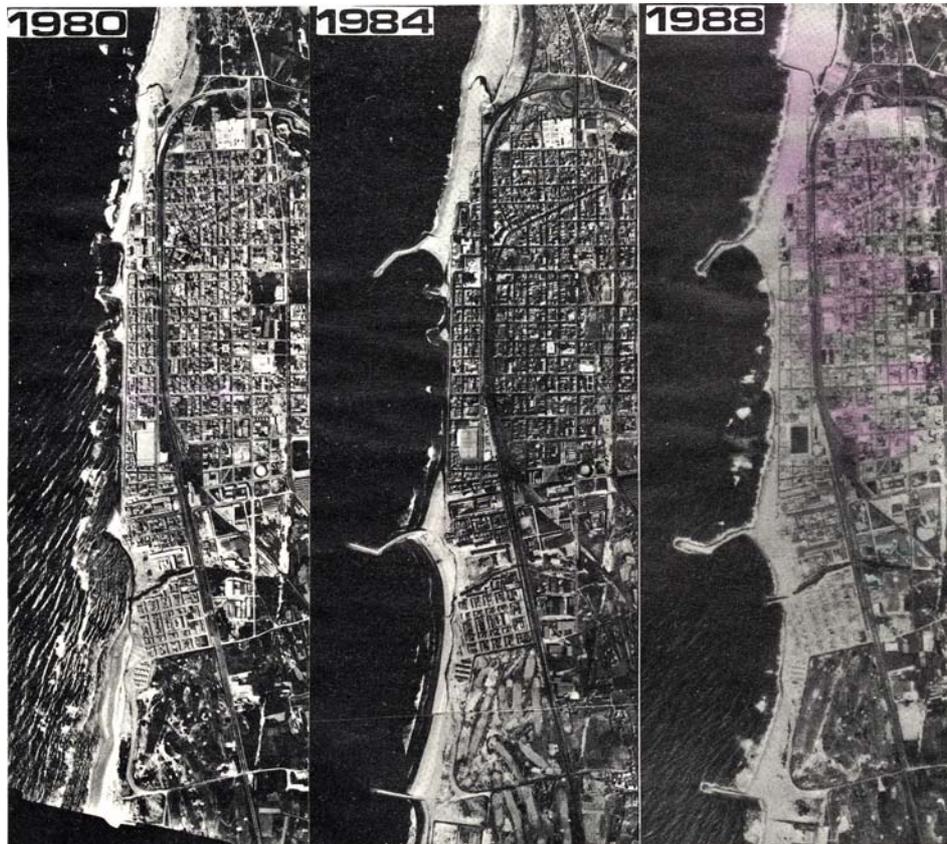
Figure 4. Effect of the coastal defences on the shoreline (Mota Oliveira & Martins, 1991).

This coastal stretch is mainly a sandy coast with no natural rock protection and is therefore very vulnerable to erosion in conditions of poor sediment availability. Nowadays, the city is artificially protected by two large groynes, one in the north extending for 350m and another in the south for 400 m, and a 400 m seawall. The situation is now considered to be stable thanks to these protections. Figures 3 and 4 show the evolution of the urban seafront of Espinho and of the protection structures between 1958 and 1988.

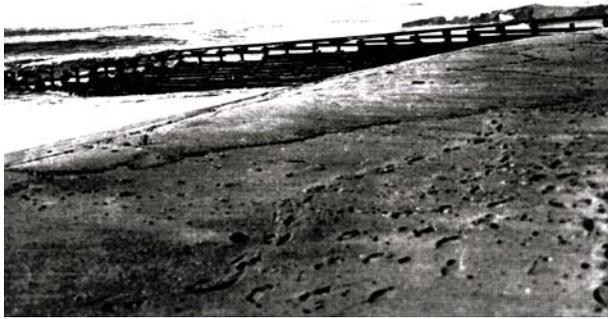
Figure 8. Experimental wood groyne.

Additional destruction led to the immediate building of two groyne, whose effect on the beach growth was already acknowledged. However, these works were not conclusive, as the groyne should have been 50m longer.

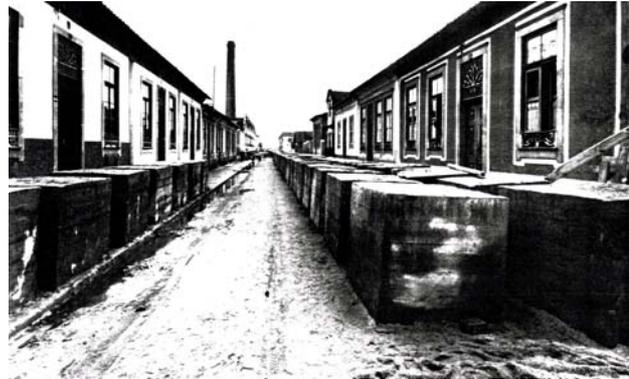
Figure 12. Concrete blocks construction.

The reconstruction/construction of the defence groynes was decreed, which meanwhile had been practically destroyed. This reconstruction was done on concrete blocks, taking advantage of existing rocks as foundations. The north groyne was 150m in length, and had 8.25m crest height on the root and 4.17m on the head. The south groyne was also 150m in length, with crest heights of 8.85 m on the root and 2.87 on the head. Updrift of the south groyne the construction of a third groyne was started, but never finished. Downdrift of the north groyne two other groynes were built, one of which was partially destroyed almost immediately upon construction because its foundations did not reach bedrock.

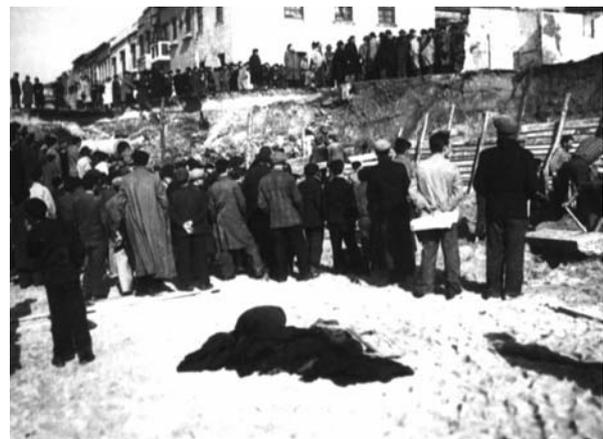
Figure 14. Wood protection.

The final defence plan was approved and work began with the construction of a 4m-wide seawall on rock foundations updrift the 27<sup>th</sup> St. groyne. This work replaced the wooden retaining wall.

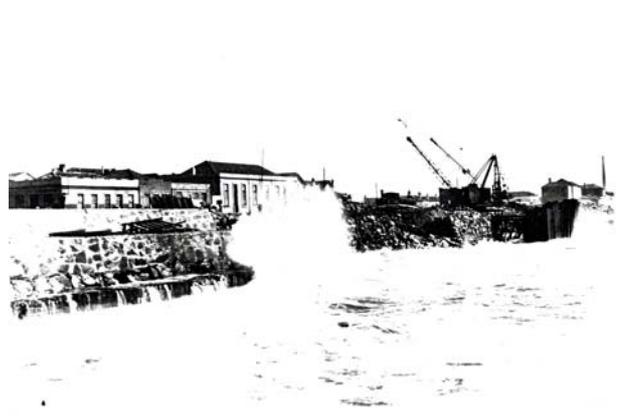
Figure 16. 2<sup>nd</sup> street in 1949.

The south part of the wall was concluded and the waves did not cause problems. However, the north section was severely battered. The esplanade was opened to the public in the summer and during the winter it was almost destroyed. The spring tides caused the destruction of almost all the wood groynes, and the ones located on 27<sup>th</sup> and 33<sup>rd</sup> streets proved to be insufficient and had to be replaced by a more solid groyne.

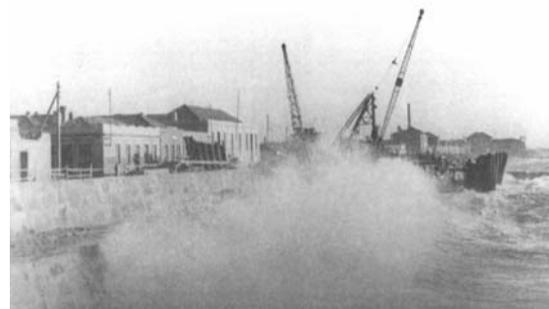
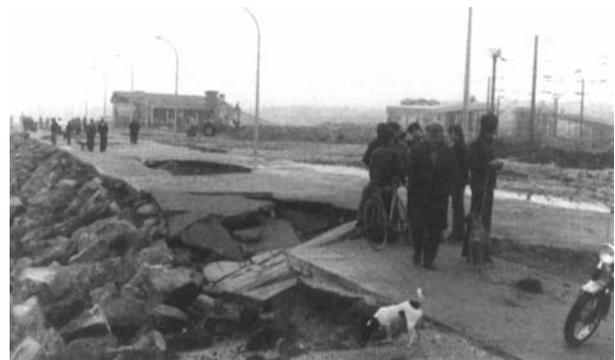
1981 – 1983

Construction of four larger groynes with tetrapod heads.

Significant damage on the head of the north groyne.
